# The 2017 Oroville Dam Spillway Incident – What Happened and What Should We Learn?

John W. France, PE, D.GE, D.WRE  
JWF Consulting LLC

Maryland Dam Safety Training  
14 November 2018

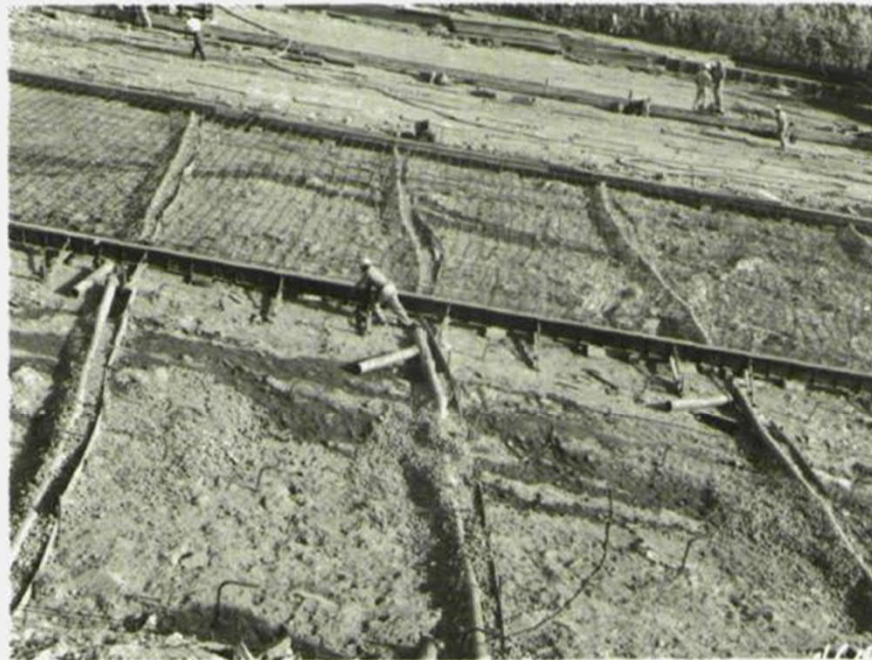
Photo 39. Chute foundation in vicinity of Sta. 33+60.  
Tile and gravel underdrains in lanes 2 and 3, rebar in  
lane 3. View southeast.  
Neg. No. 4644

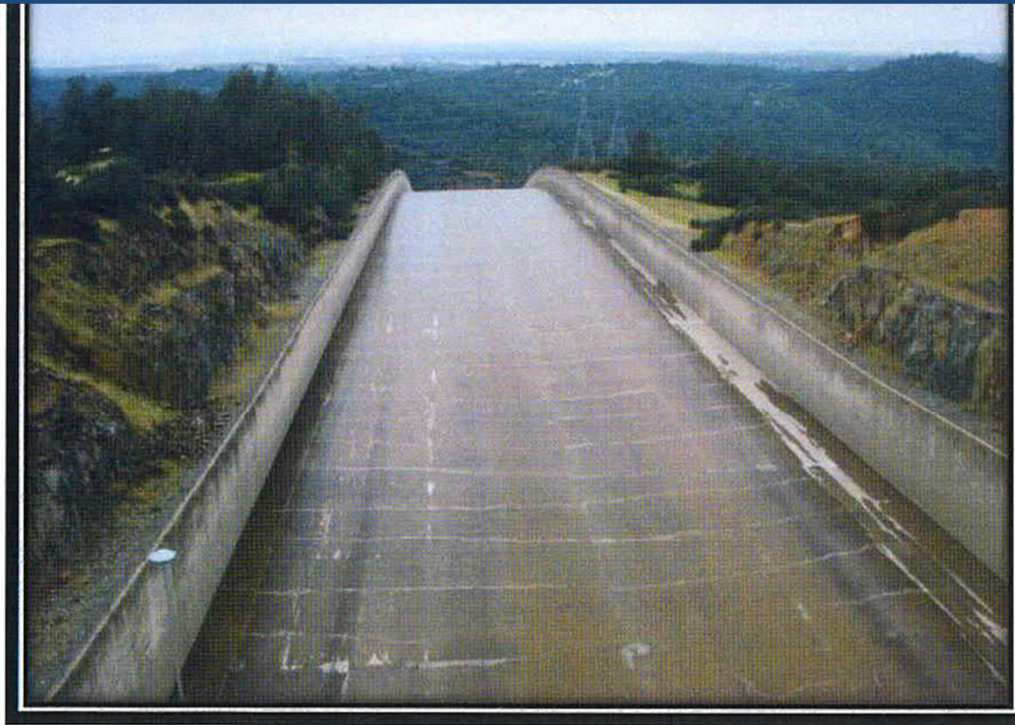
# Crack Pattern in SS Chute

12. The concrete along the spillway chute has been repaired. The repaired herringbone crack pattern is said to reflect the underlying drain system.

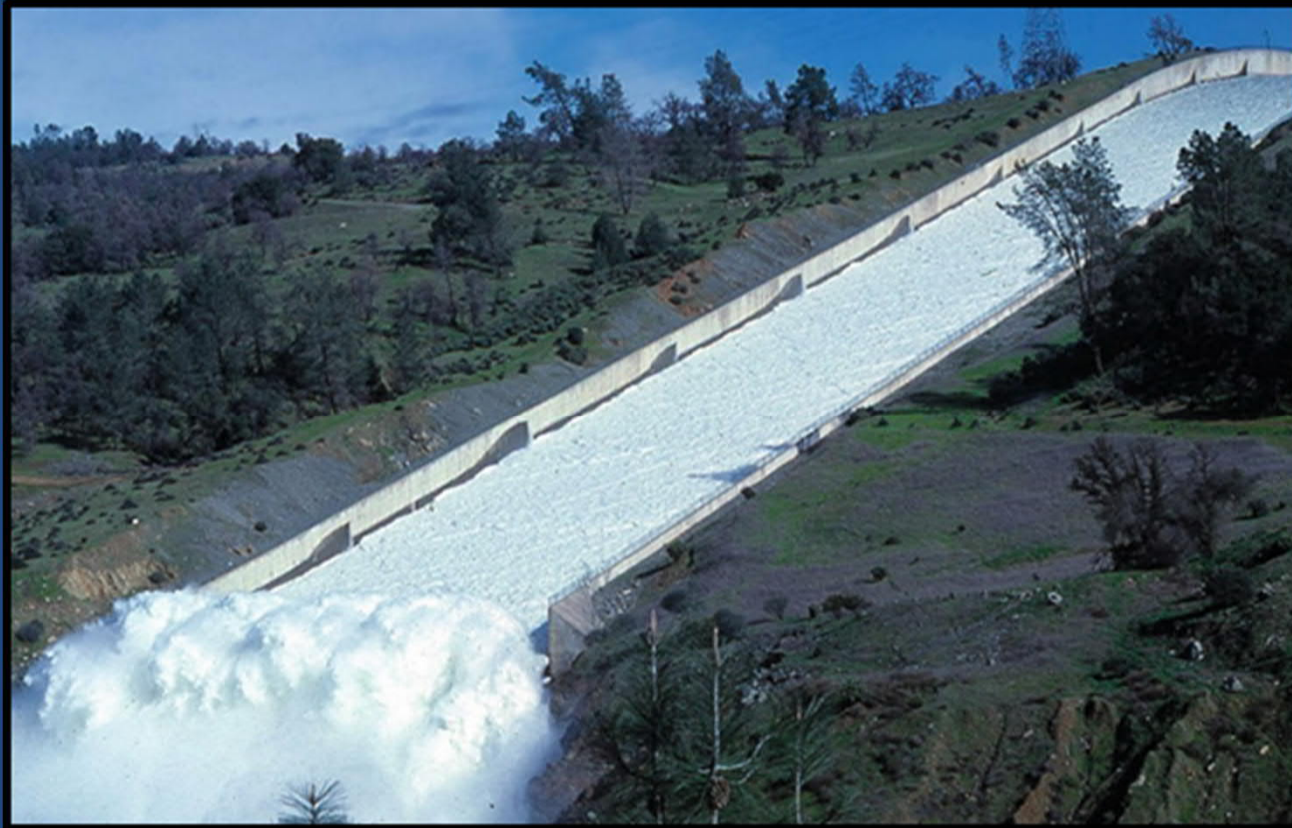
# SS Underdrain Flows

- Drains flow heavily when SS is discharging
- Flow is from leakage through the slab into the foundation
  - Joints
  - Cracks
- Gates leak when closed

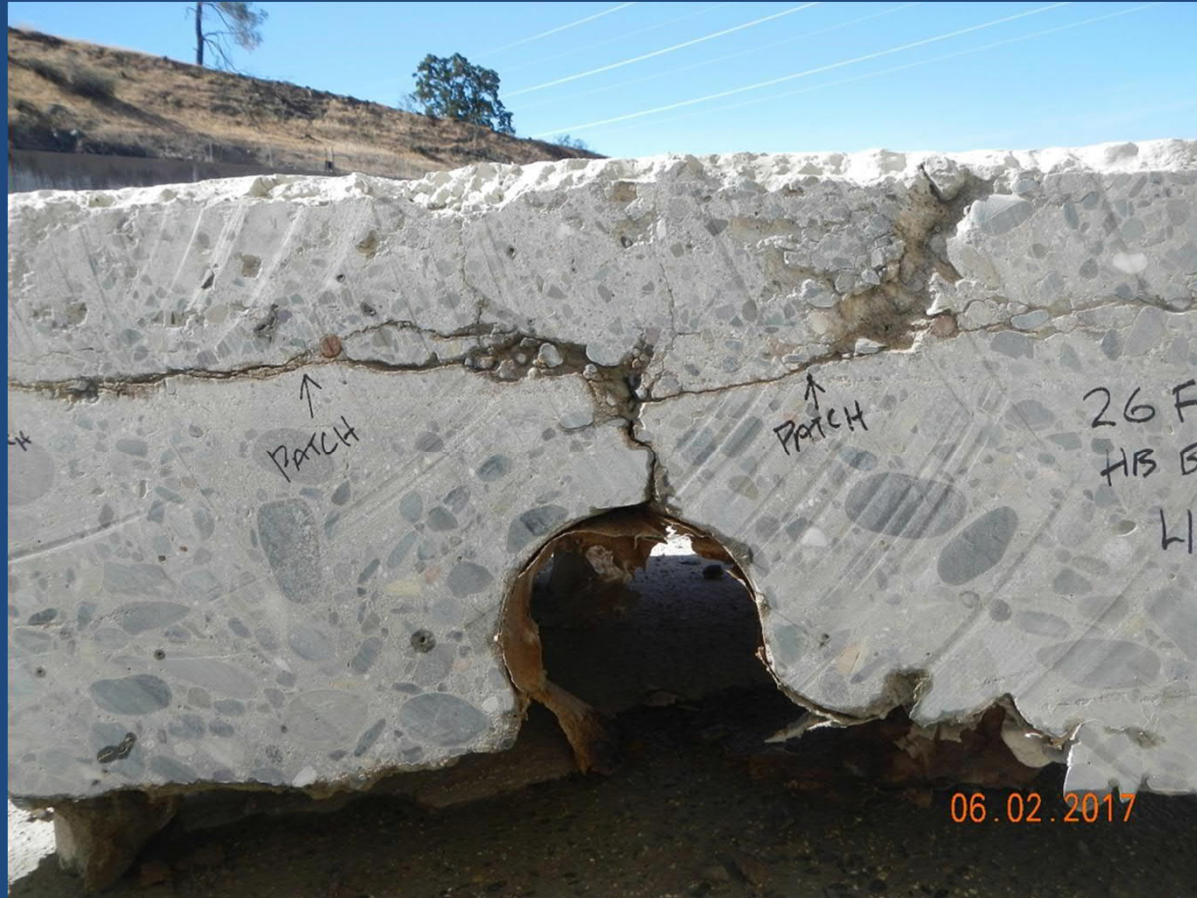
# Durability of Repairs

- Repeated cracking and spalling in old locations plus cracking and spalling in new locations
- Relationship to original design not clearly recognized
- Long term deterioration of slab condition not recognized
- Repairs were effectively “band aids” which did not address root causes
