PHASE I ENVIRONMENTAL SITE ASSESSMENT
FORMER GINN'S OFFICE SUPPLY WAREHOUSE
5620 AGER ROAD
HYATTSVILLE, MARYLAND 20782

Prepared for:
HYATTSVILLE LAND COMPANY

JOB NO: 33039-001-122
MAY 21, 1996

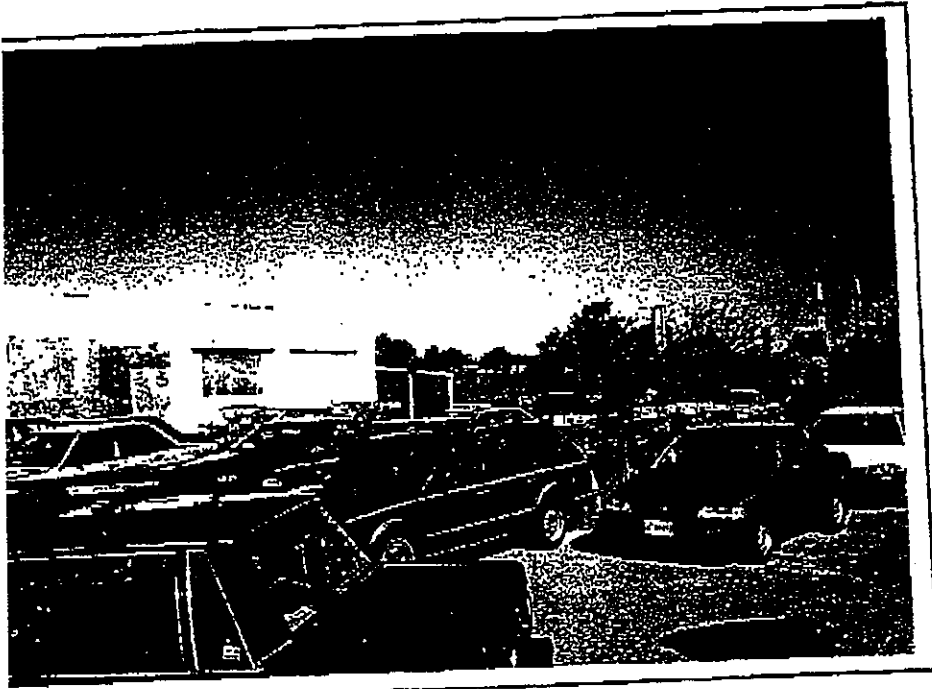
PHOTOGRAPH 5: Abandoned Chevron service station located on adjacent property to the southeast.
