Response Action Plan

**Talbot Properties, LLC VCP
9120 Talbot Avenue
Silver Spring, MD 20910**

CLENDENIN CONSULTING & REMEDIATION GROUP
P. O. Drawer 6070
Leesburg, Maryland 20178-7406

August 7, 2020
18006.RAP

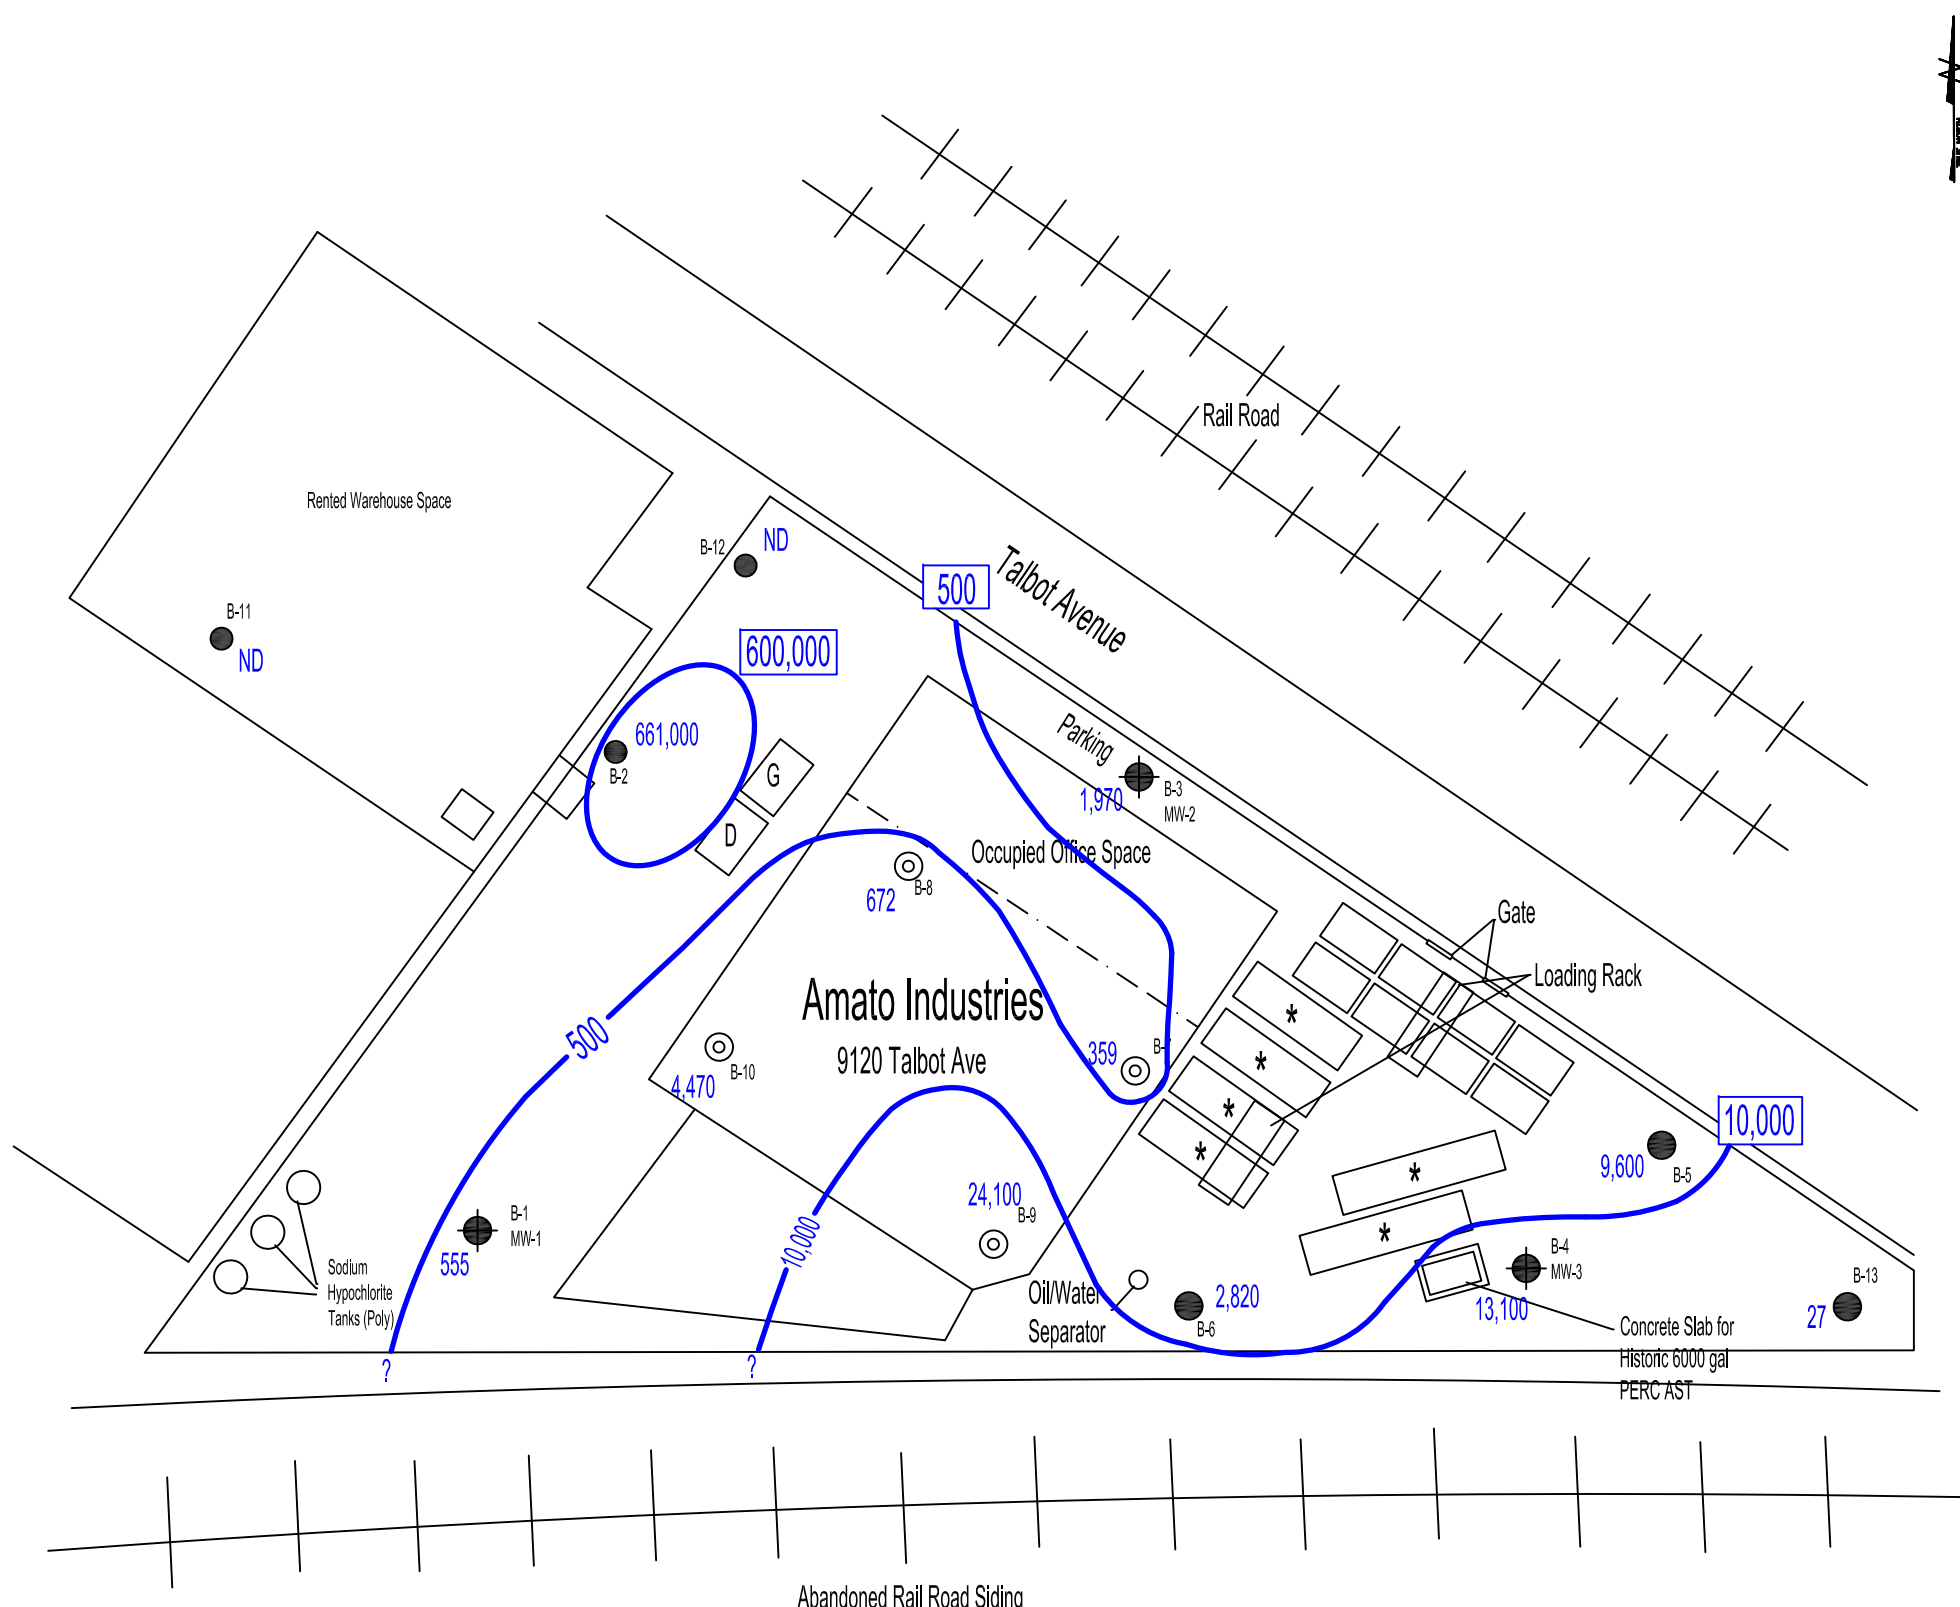
CCRG Clendenin Consulting & Remediation Group	
Talbot Properties, LLC VCP	
Trichloroethene(TCE) Soil Gas Concentrations	
Silver Spring, Maryland	
Date: 4/4/2019	Scale: 1" = +/- 40' (scale approximated)
Drawn by: SJK	Approved by: BEC
Project #: 18006	Figure: 8

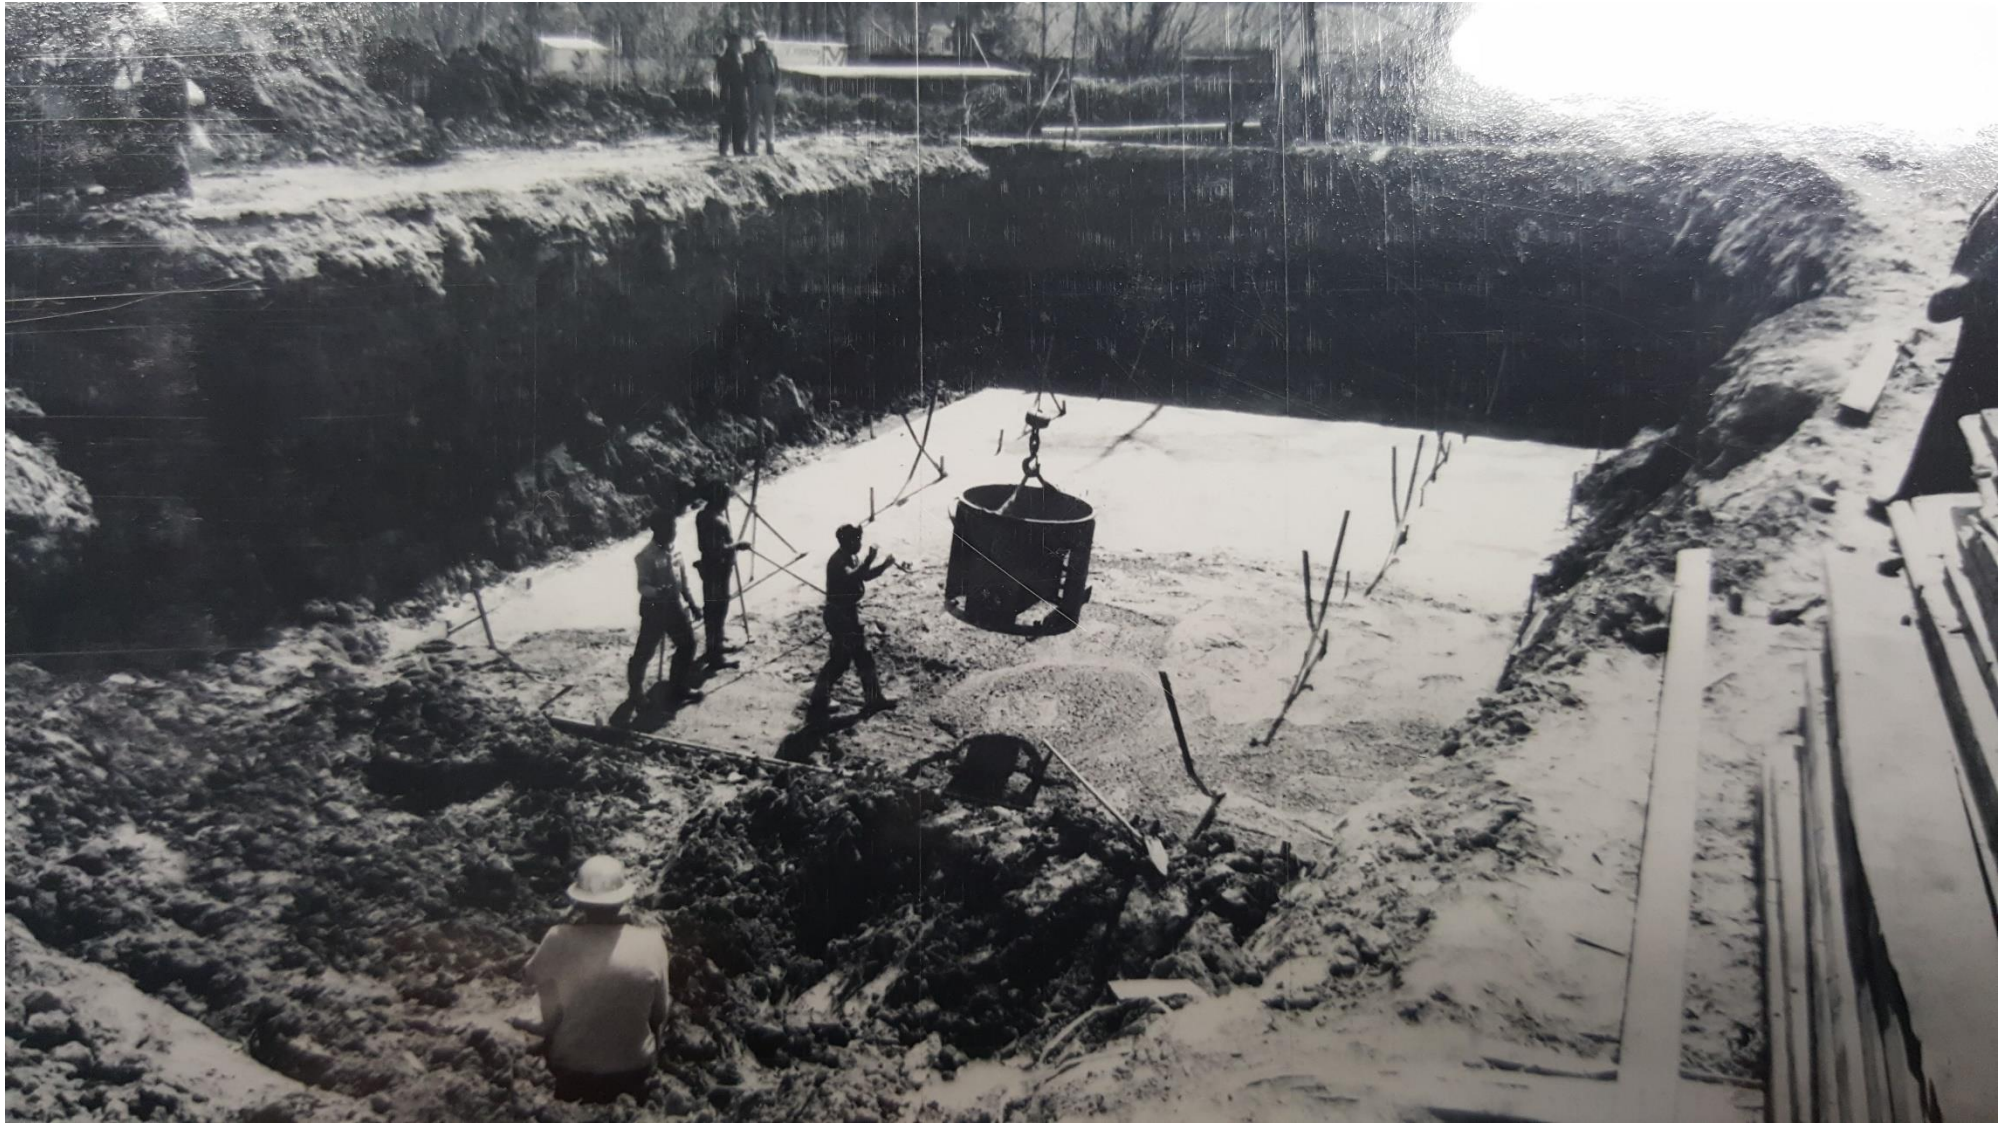
P1

Hold Down Concrete Slab Construction

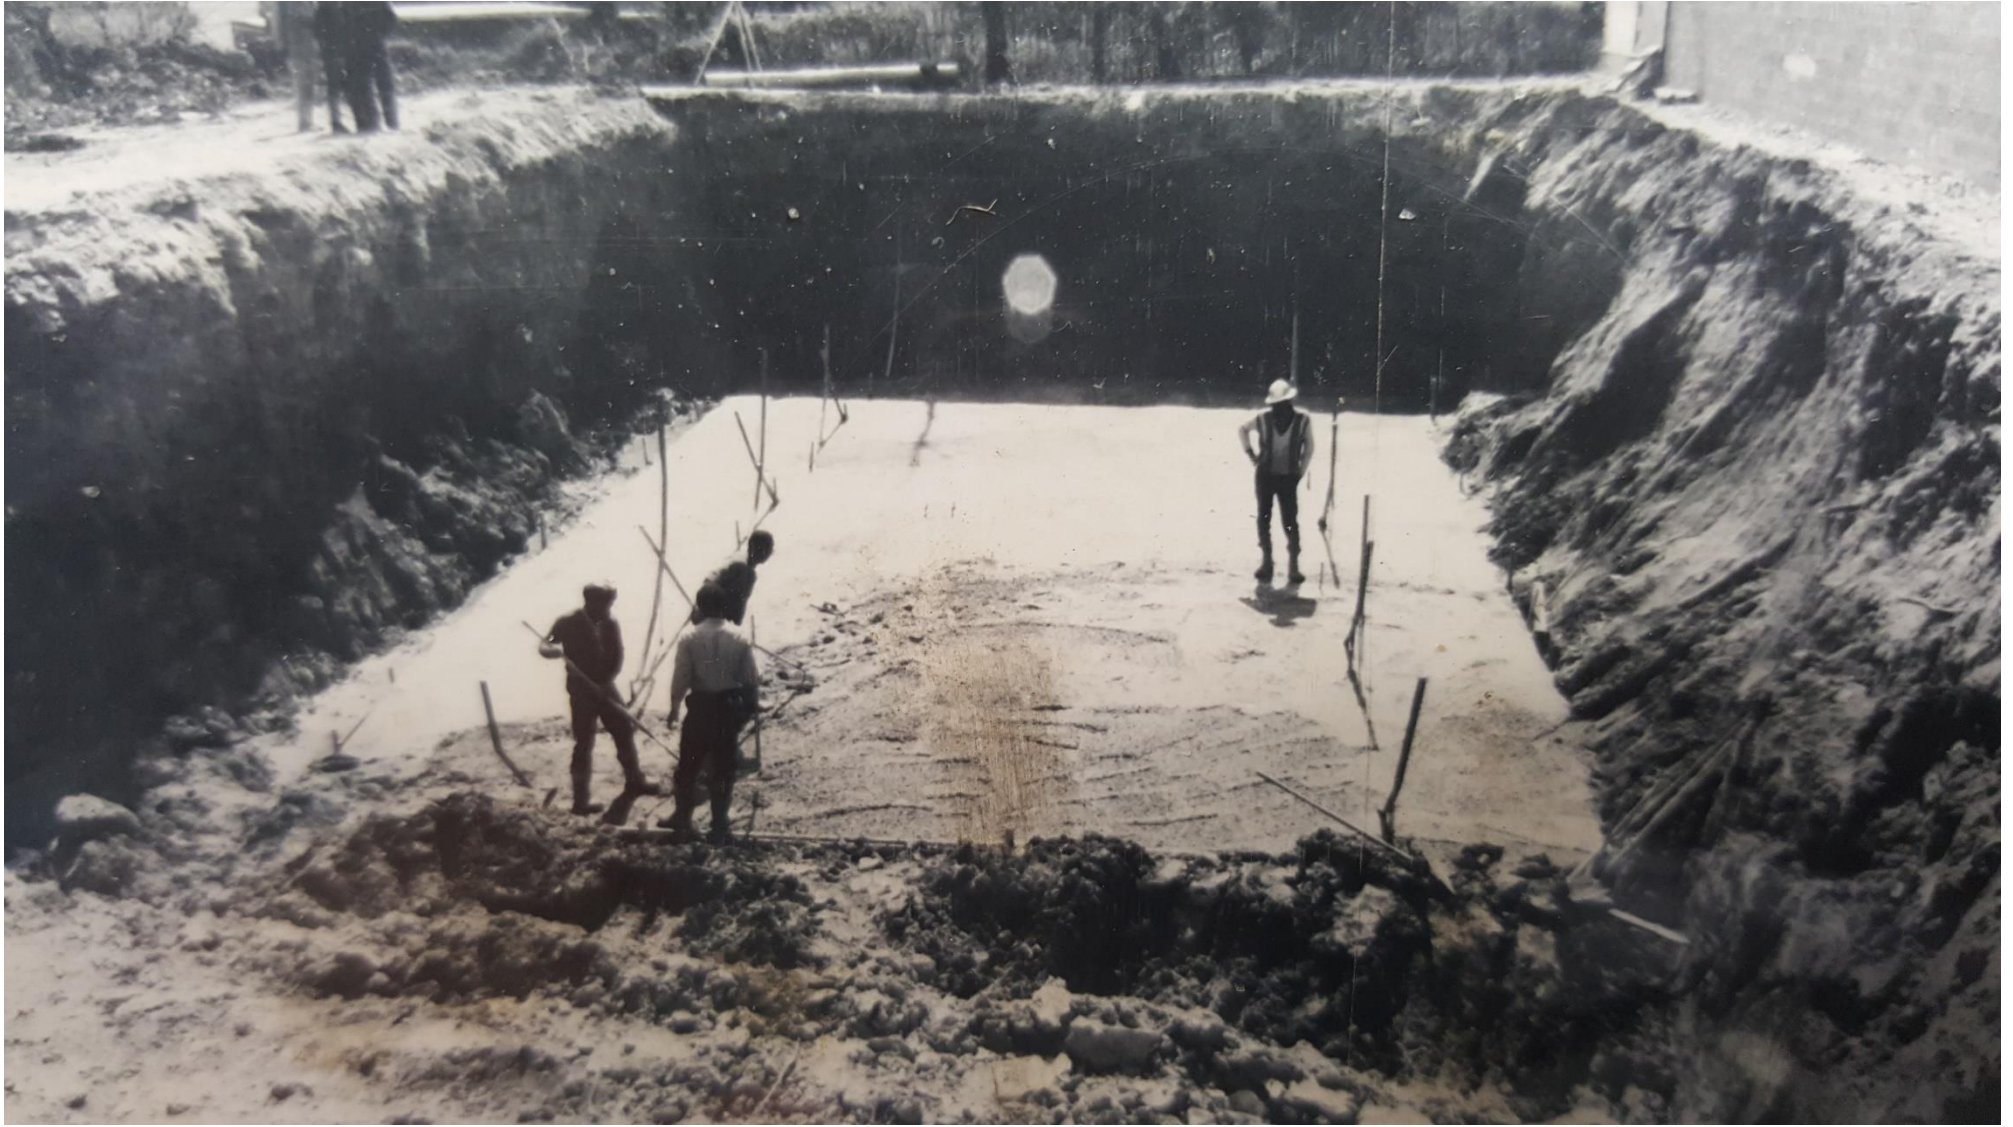
P2
Hold Down Concrete Slab with Straps

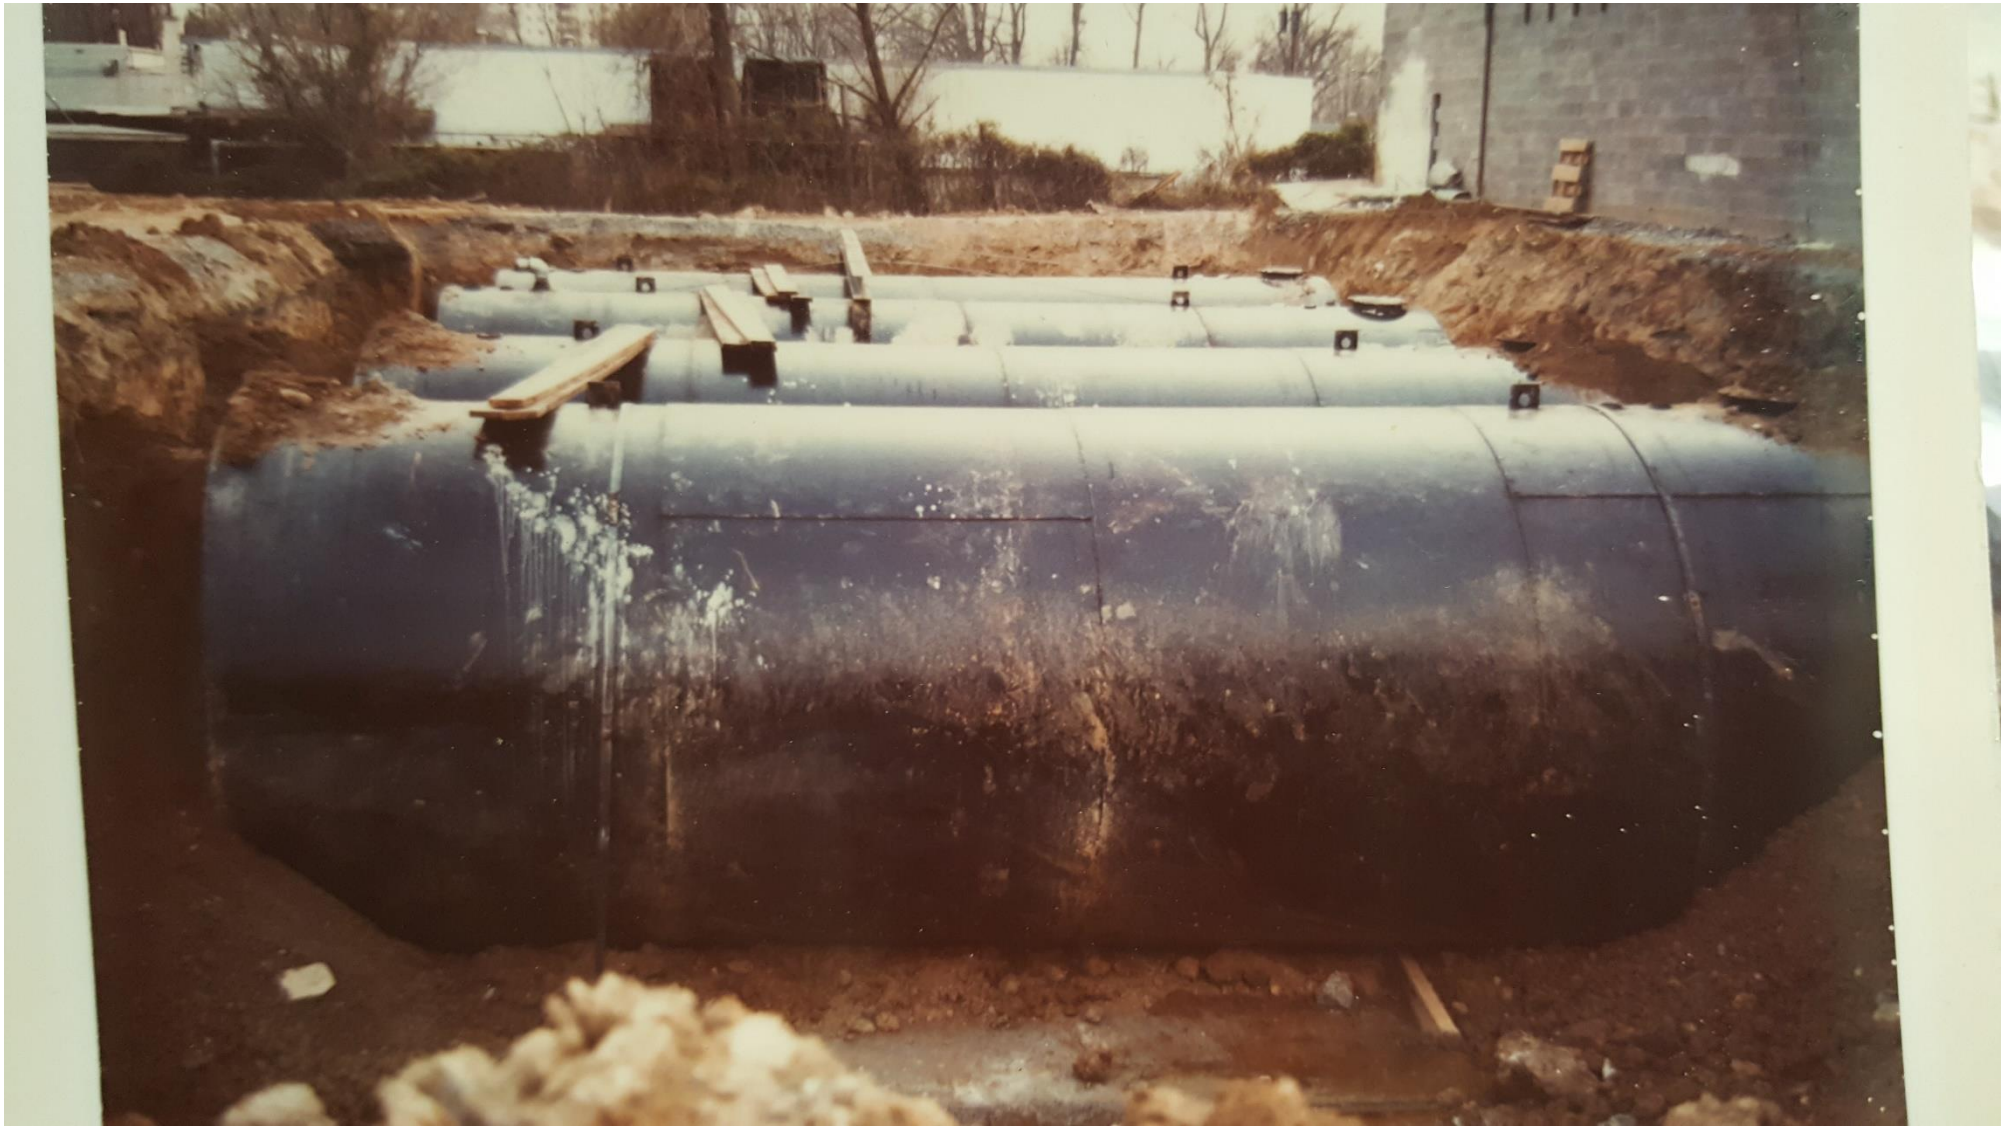
Tank Installation- No Groundwater Visible

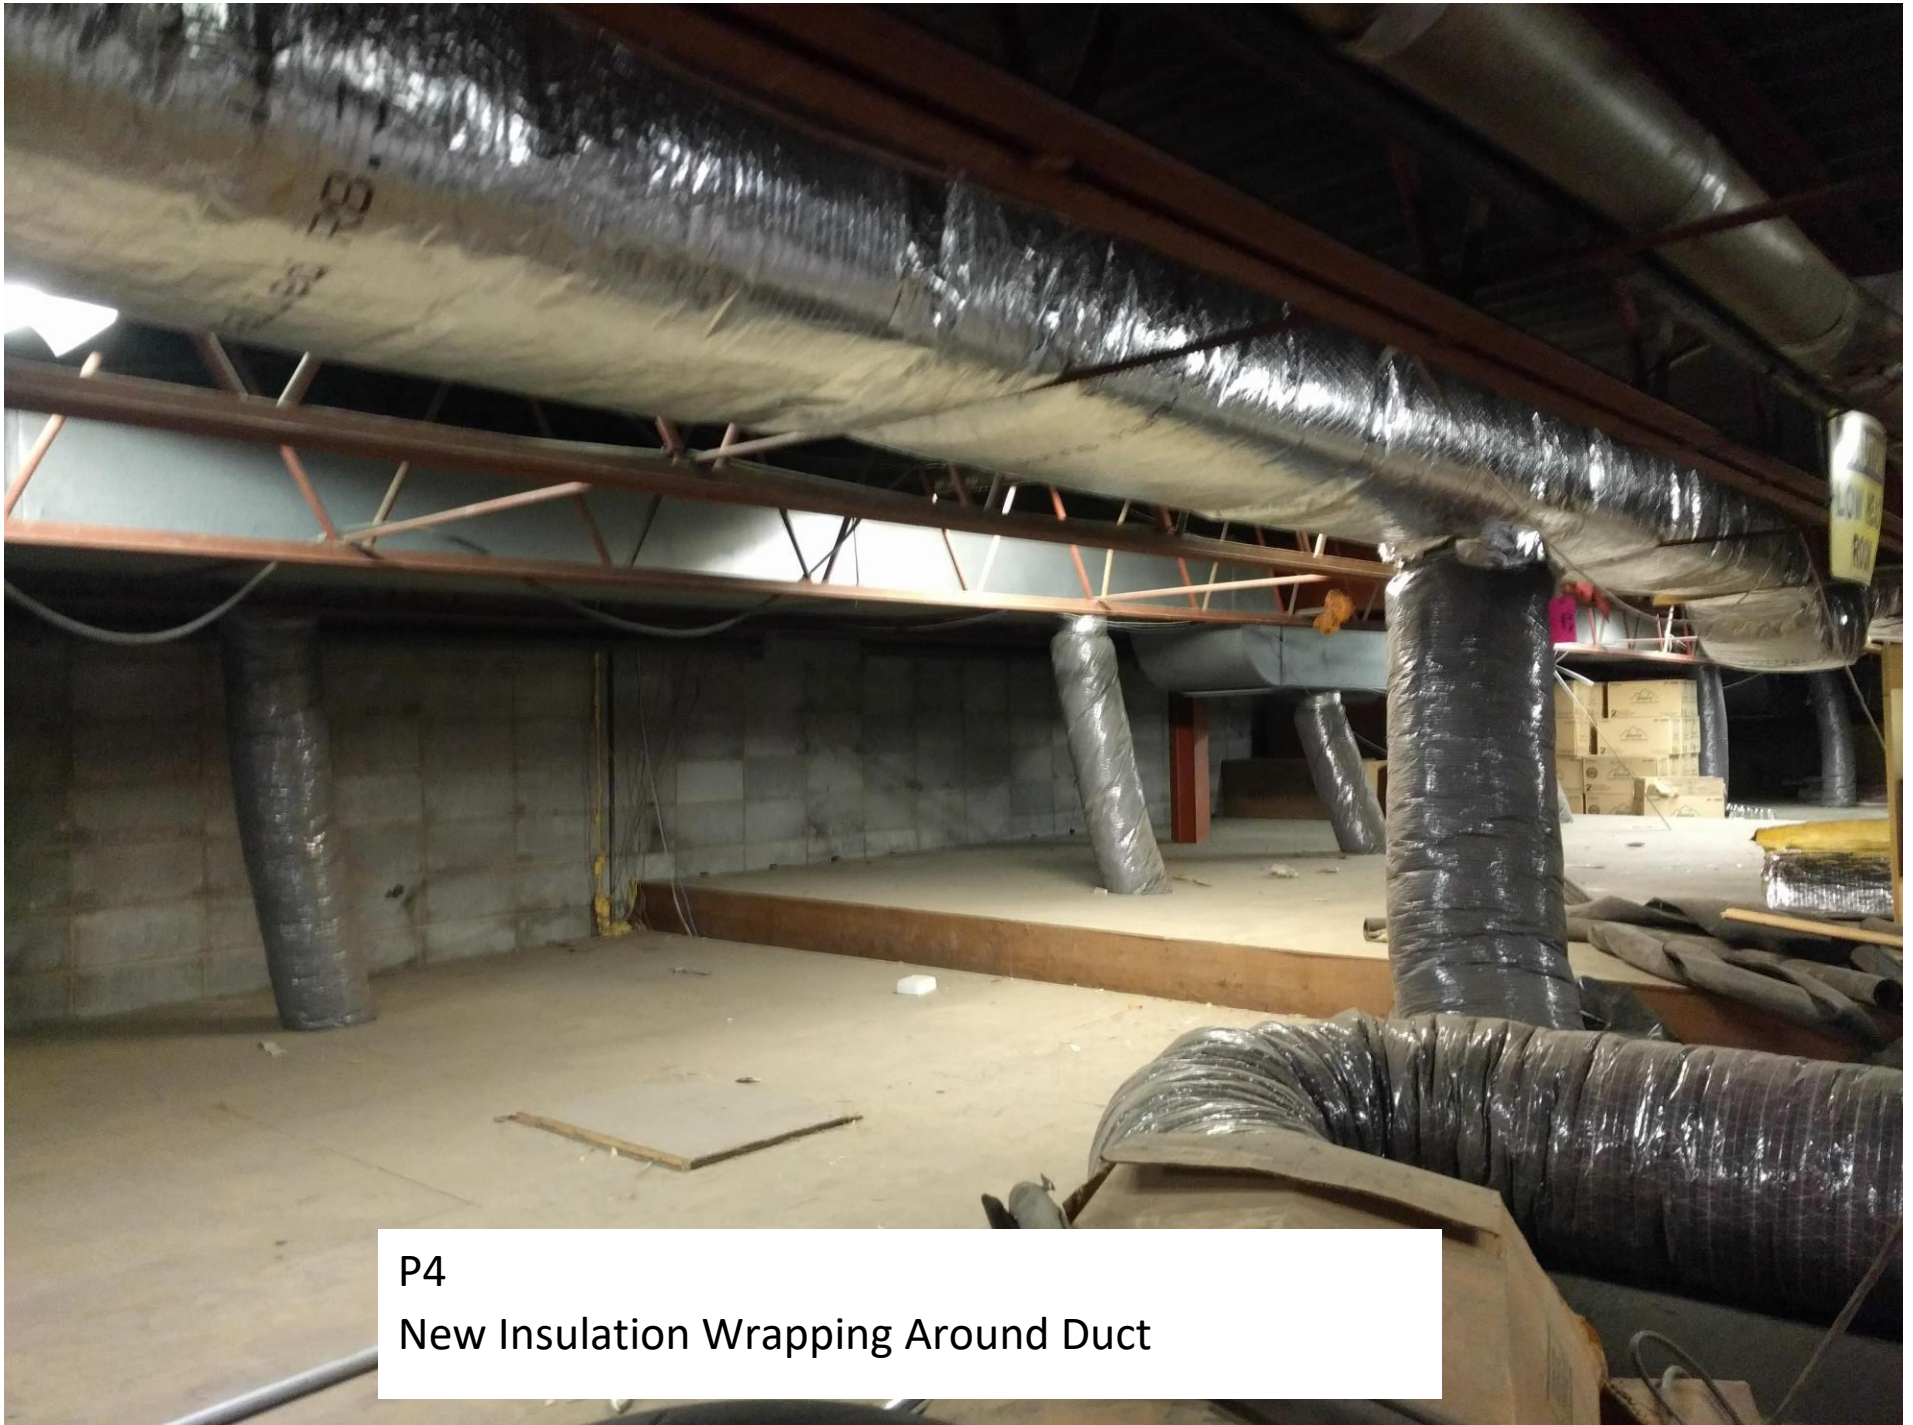
P4
New Insulation Wrapping Around Duct

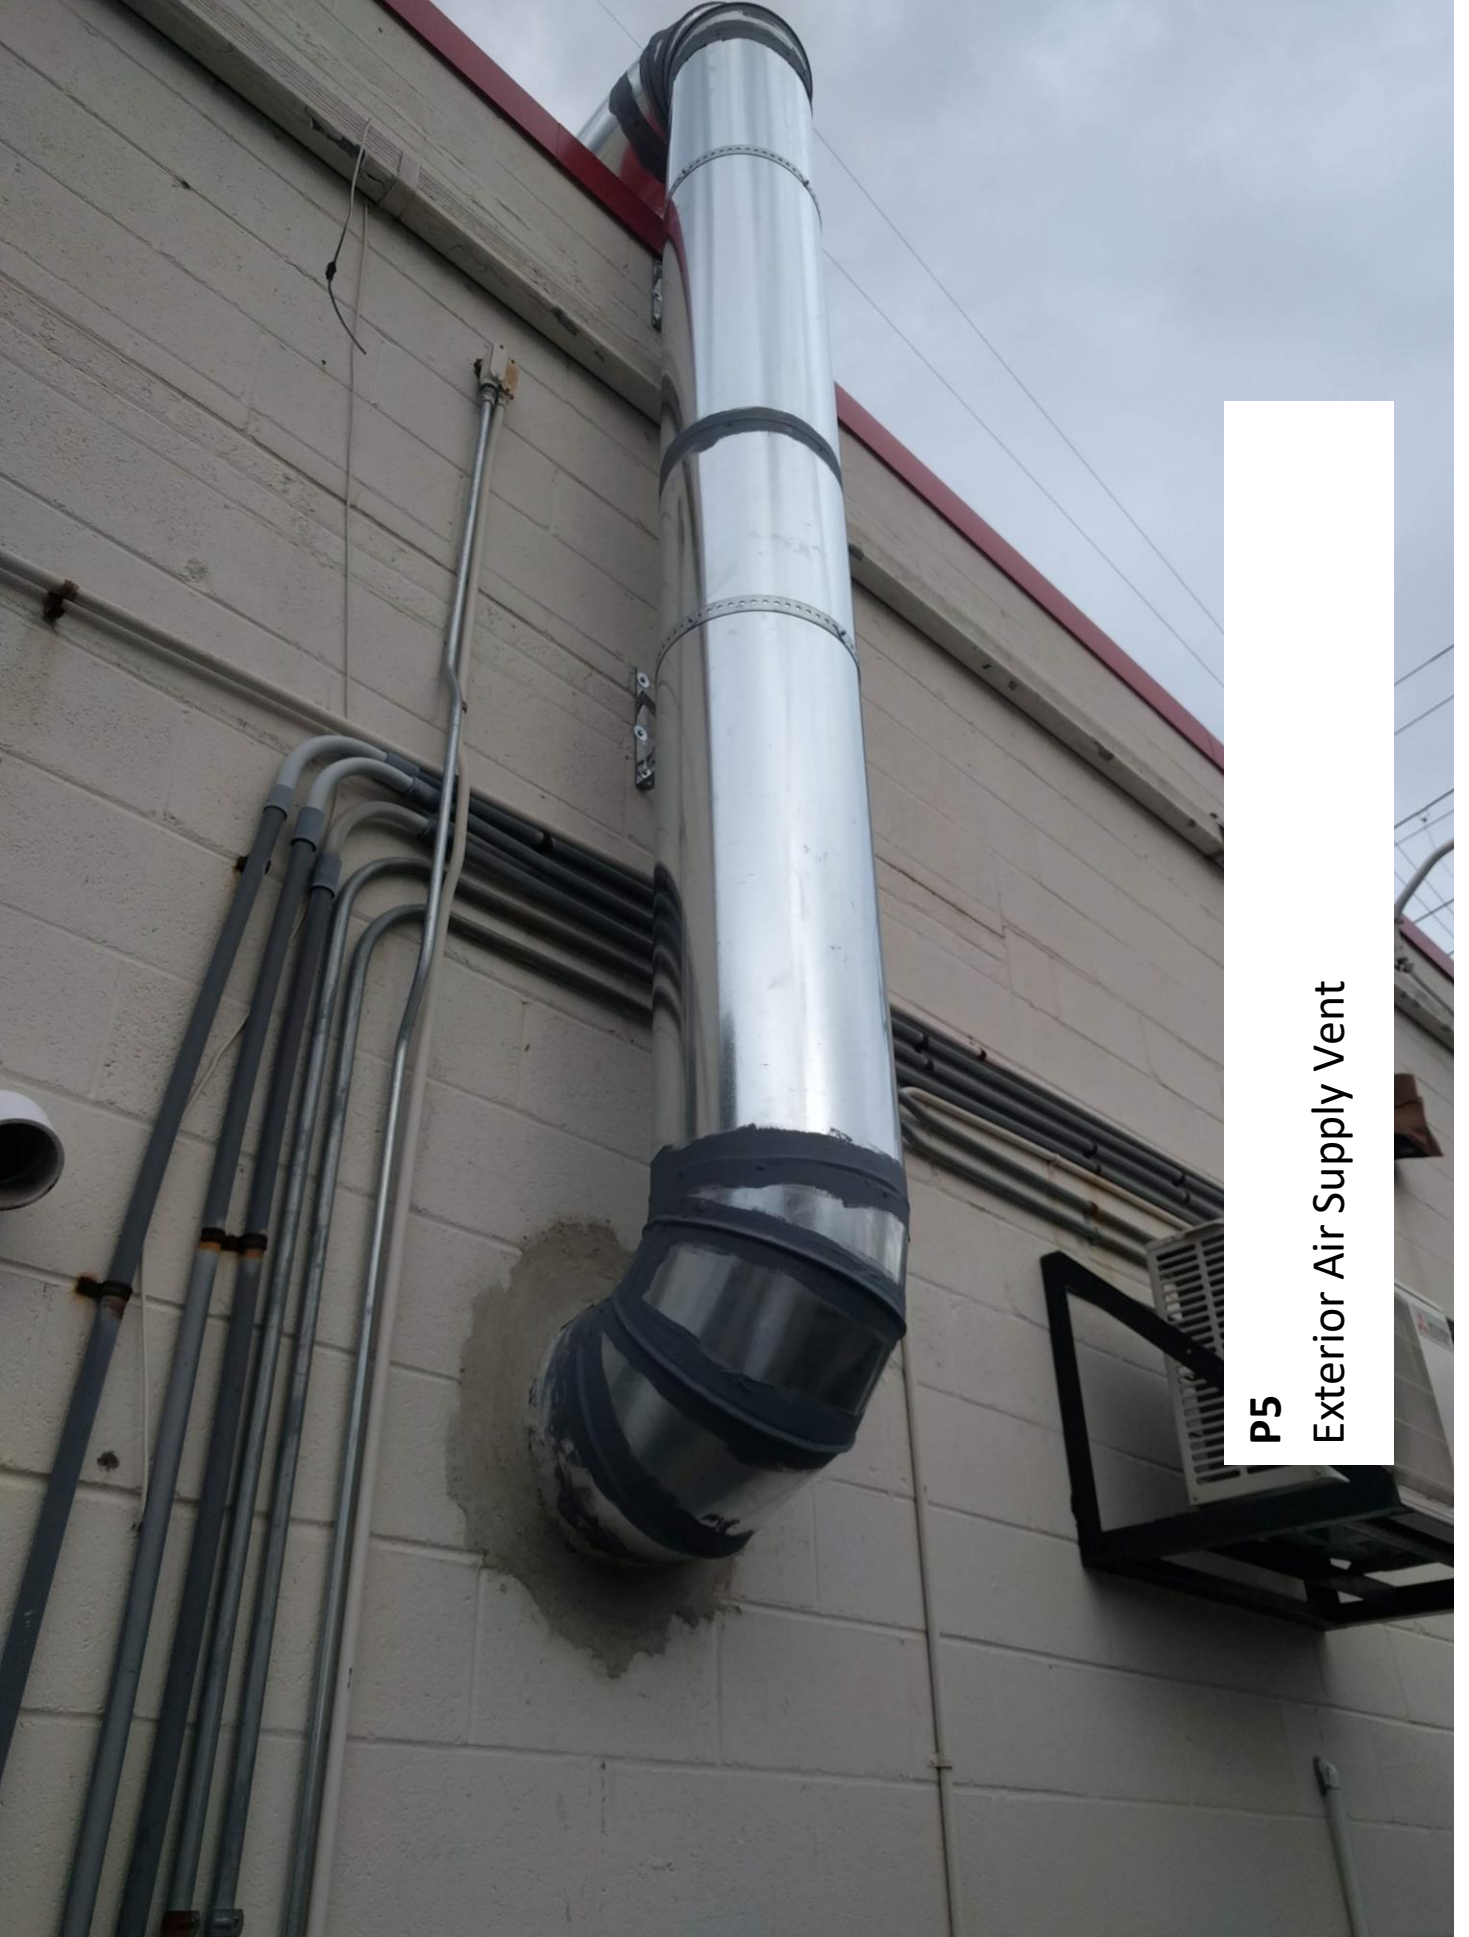
P5

Exterior Air Supply Vent

The Pilot Test involved activating a temporary fan upgrade to the existing HVAC system which introduced 300 CFM of additional outdoor air into the Amato office. The fan was installed on June 10, 2019 and activated on June 20, 2019. The fan was allowed to run for 5 days before the indoor ambient air samples were collected. The fan was shut off after the sampling was completed to prevent humidity buildup problems. Round #3 air sampling was performed on June 25, 2019 at the same sample locations used during Round #2. The samples were designated A-10 and A-11. The canisters were sent to Eurofins for analysis using EPA Method TO-15 using GC/MS full scan mode method. The laboratory test results indicate a decrease in all chlorinated compounds as shown on Table 1-Exhibit 6.

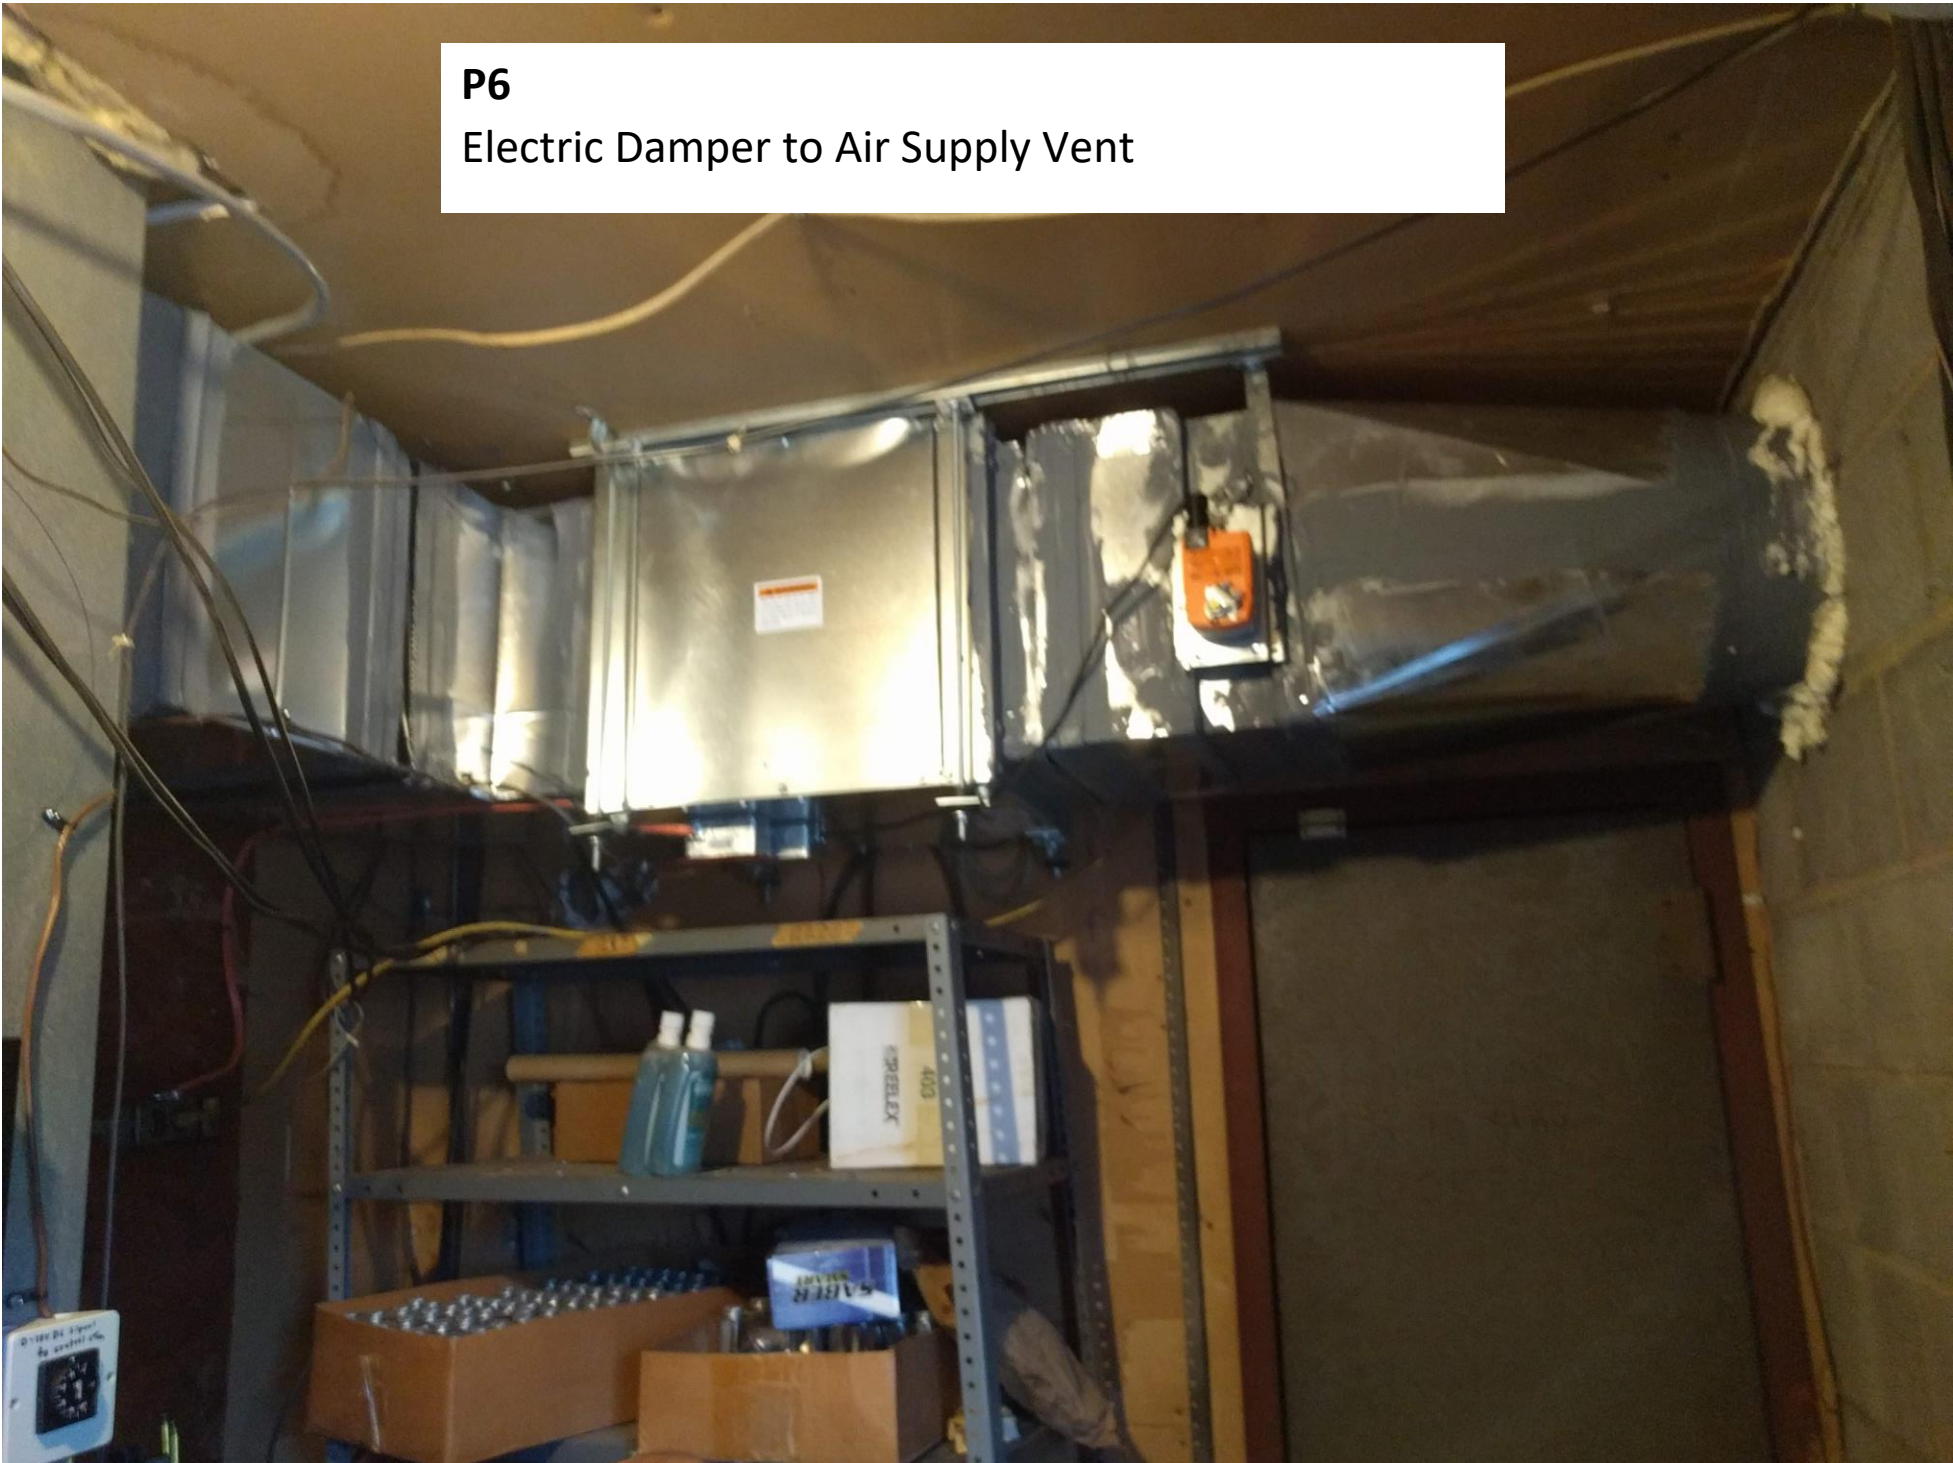
P6
Electric Damper to Air Supply Vent

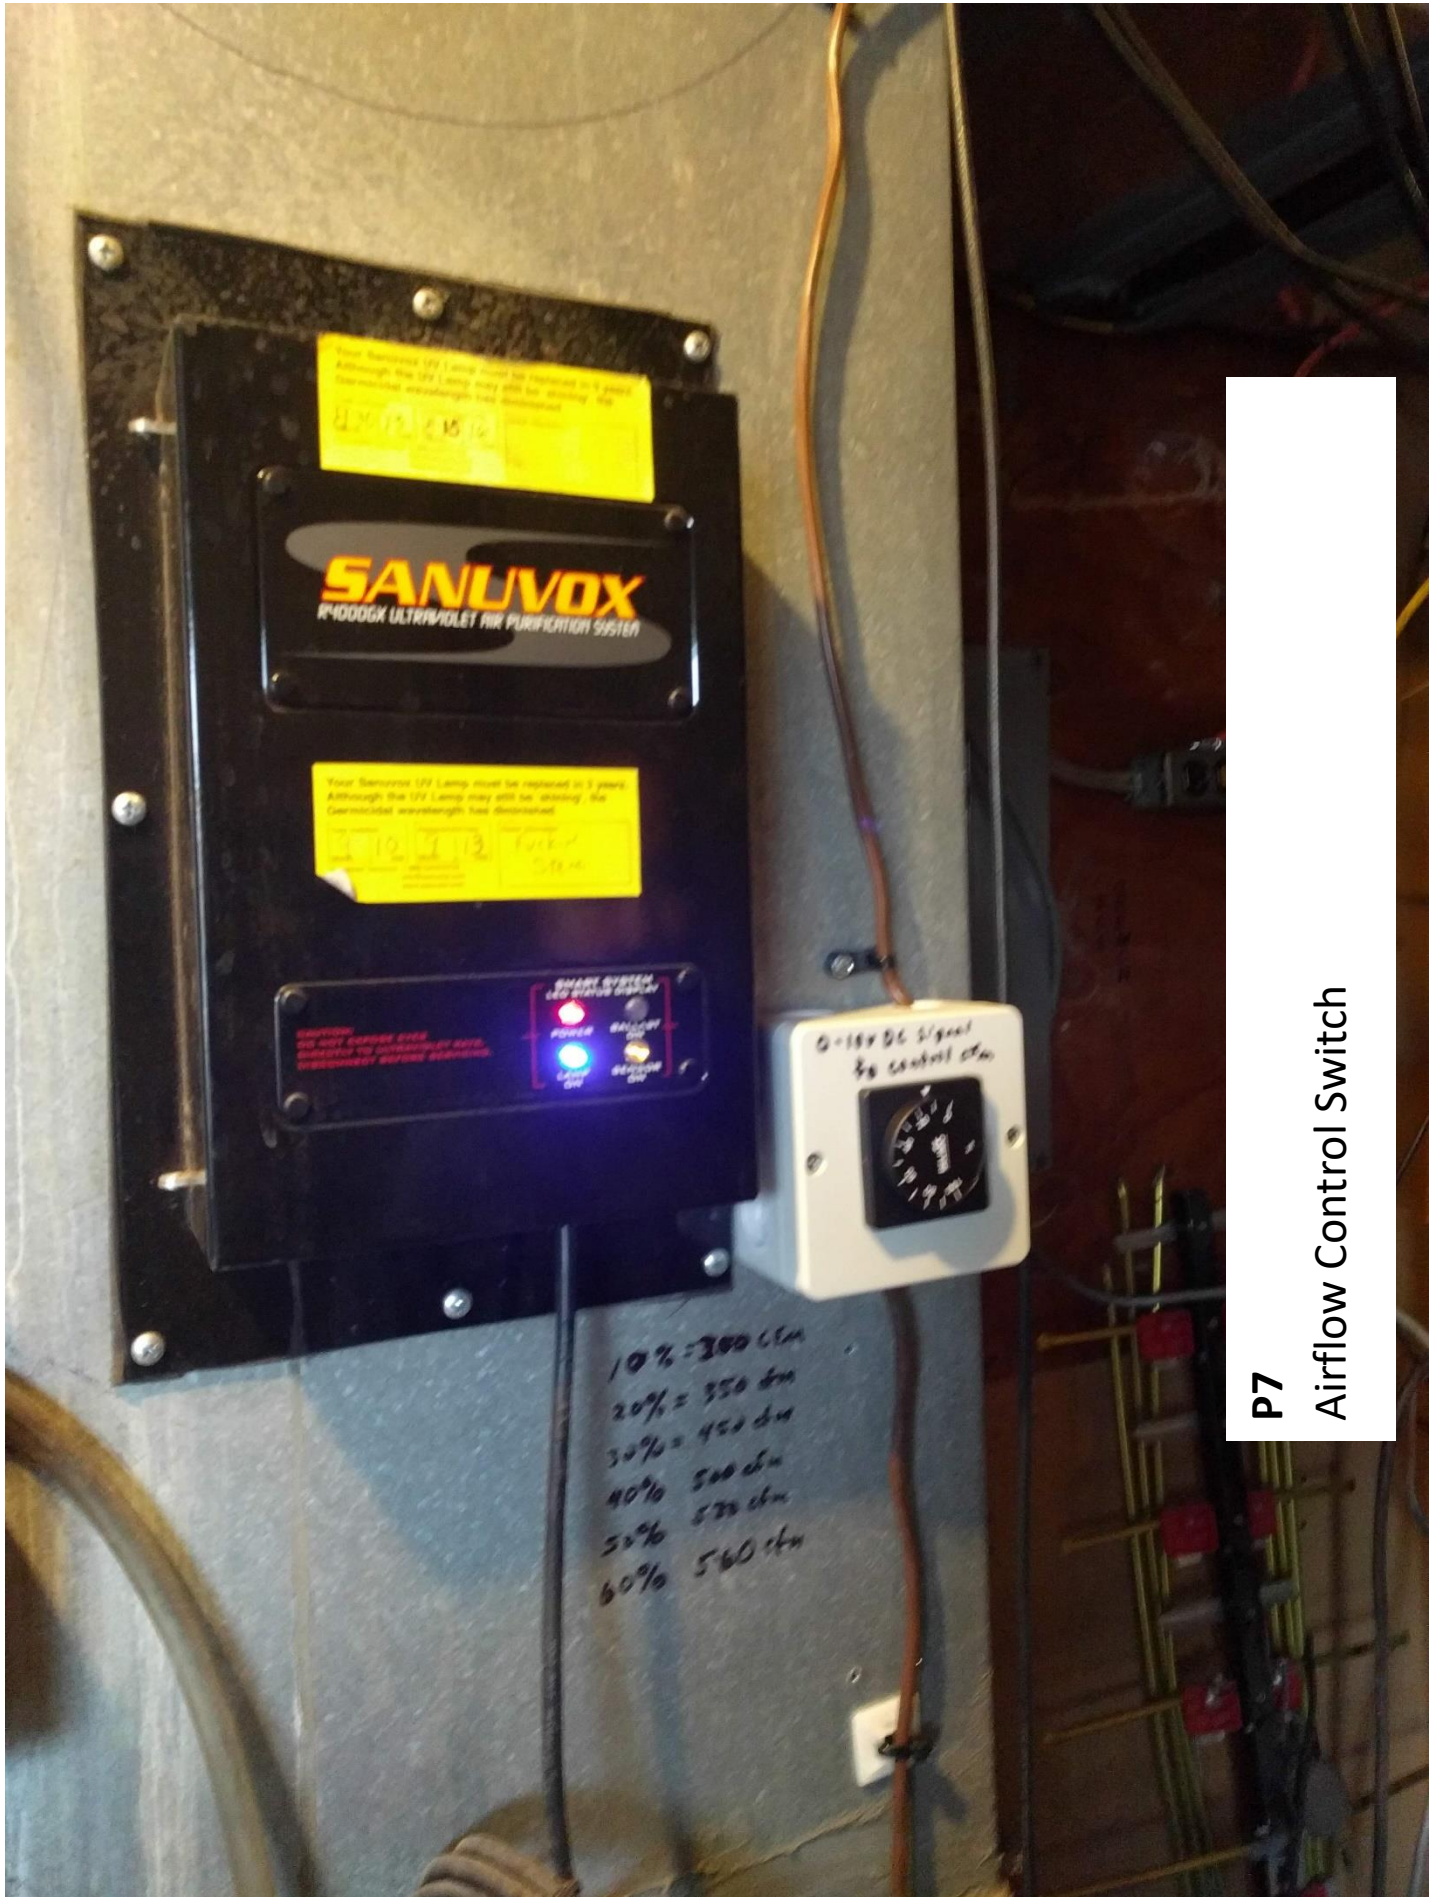
10% = 300 CFM
20% = 350 CFM
30% = 400 CFM
40% = 500 CFM
50% = 550 CFM
60% = 560 CFM

P7
Airflow Control Switch
