Maryland Department of the Environment
Water and Science Administration
Water Supply Program
Gregory Busch, Acting, Manager

**EVALUATION OF POTENTIAL HYDROLOGICAL
IMPACTS AND DEVELOPMENT OF SINKHOLES
CAUSED BY DEWATERING OF QUARRIES IN THE
HAGERSTOWN VALLEY, WASHINGTON COUNTY,
MARYLAND**

Patrick A. Hammond

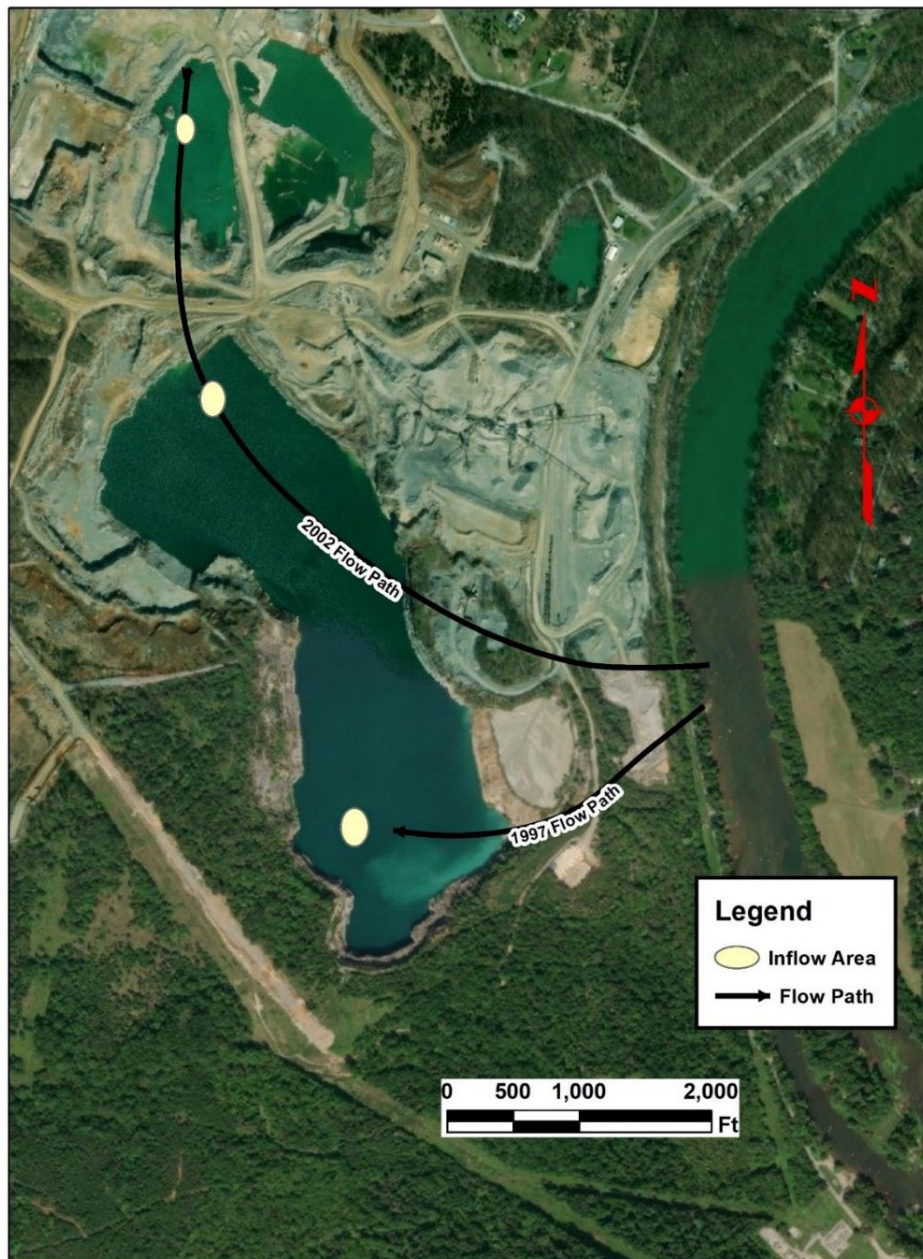
Figure 1. Aerial map of the Millville Quarry with the 1997 and 2002 flow paths from the Shenandoah River to the inflow (discharge) areas within the quarry.

Bruce et al. (2001) described the karstic conditions that formed a massive flooding flow conduit at Millville Quarry in April 1997, Figure 1, after production blasting activities and several abnormally severe precipitation events that caused flooding of the river and nearby sinkhole formation. An inflow of river water of over 35,000 gpm was halted through construction of a cement and bitumen grout curtain adjacent to the leakage area in the river.

A vortex observed previously in the river appeared to be the point source of the flow. Initially, several attempts were made to construct a cofferdam near the vortex. Such actions resulted in immediate, but temporary, reductions of the new inflow to as little as 6,000 gpm. In each case, the flow conditions were re-established within 8 to 12 hours as a new vortex re-formed, up strike in the riverbed. All the new vortex locations were all along an approximately straight line, corresponding to the regional northeast to southwest strike of the dolomite formation.

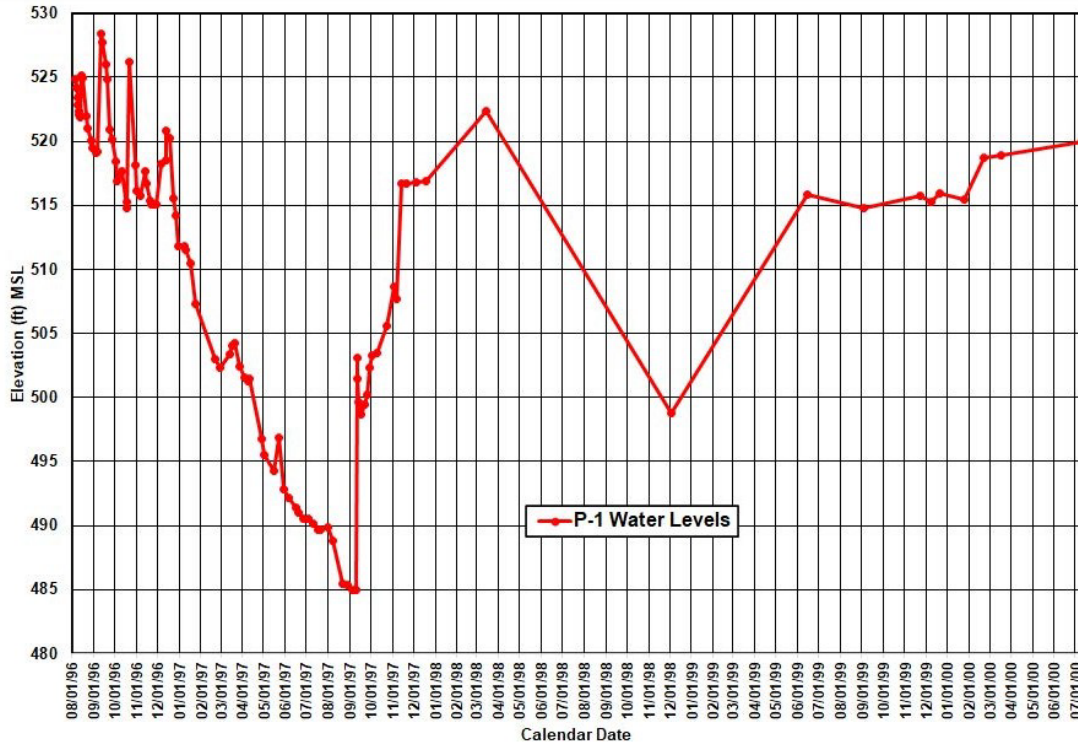
Figure 6. Beaver Creek West Quarry. P-1 monitoring well. Groundwater elevations: 08/06/1996 to 7/11/2000.

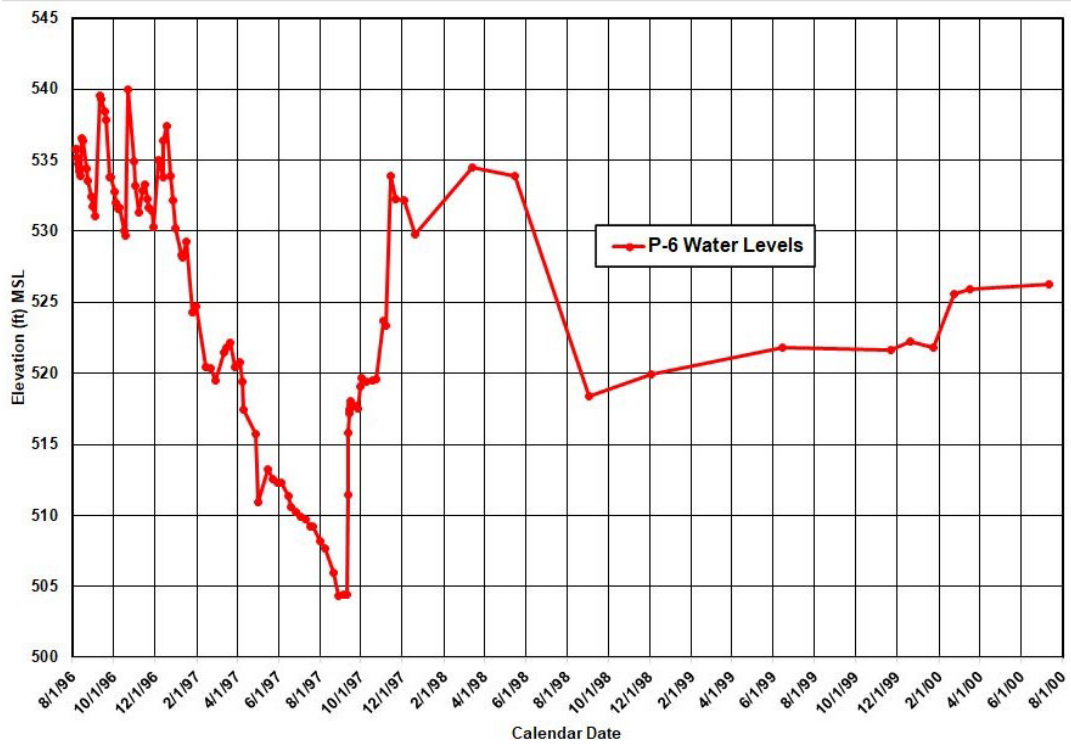
Figure 7. Beaver Creek West Quarry. P-6 monitoring well. Groundwater elevations: 08/06/1996 to 7/11/2000.

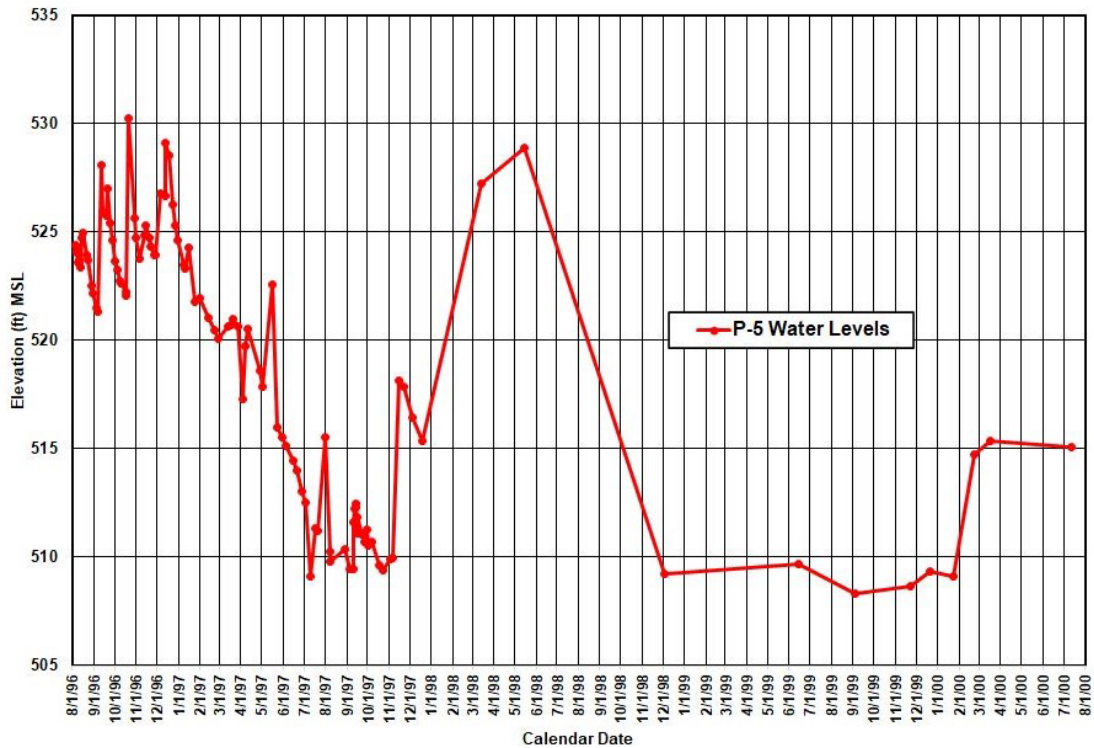
Figure 8. Beaver Creek West Quarry. P-5 monitoring well. Groundwater elevations: 08/06/1996 to 7/11/2000.

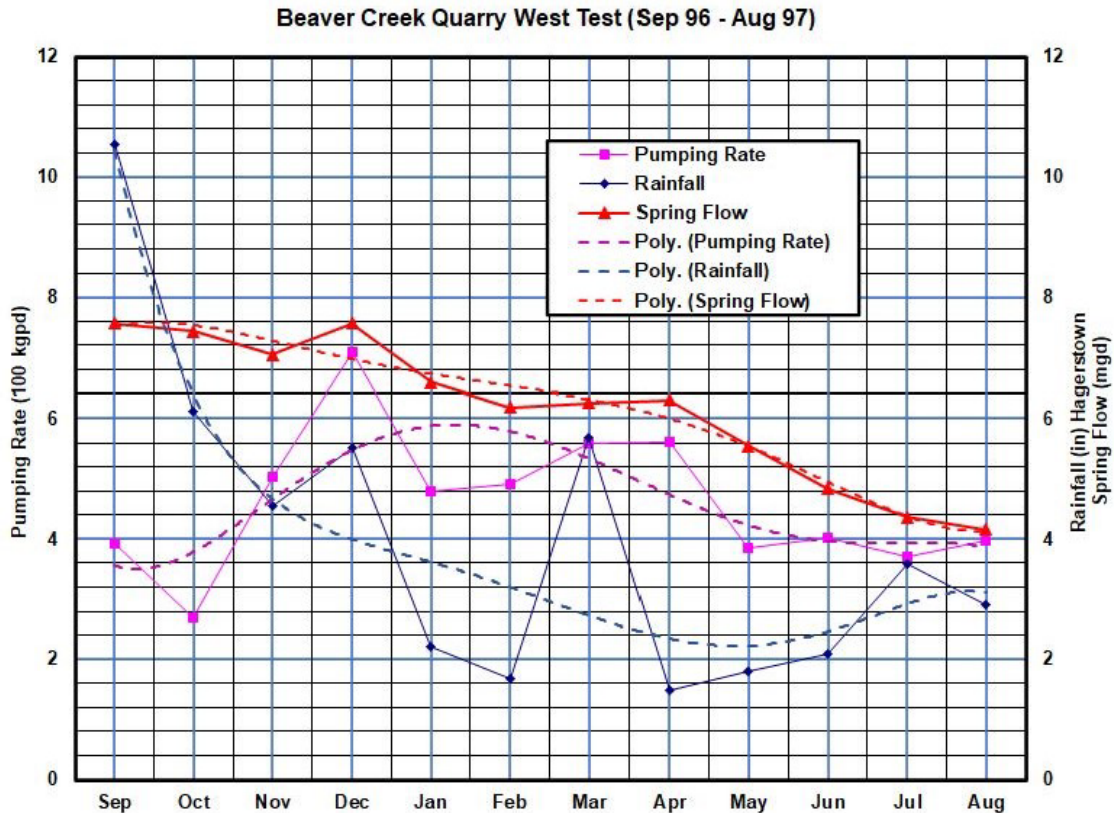
Figure 9. Monthly averages for the Beaver Creek West Quarry pit pumping rate, Albert Powell Fish Hatchery (Haupt Spring) spring flow and Hagerstown 1E rainfall: September 1996 to August 1997.

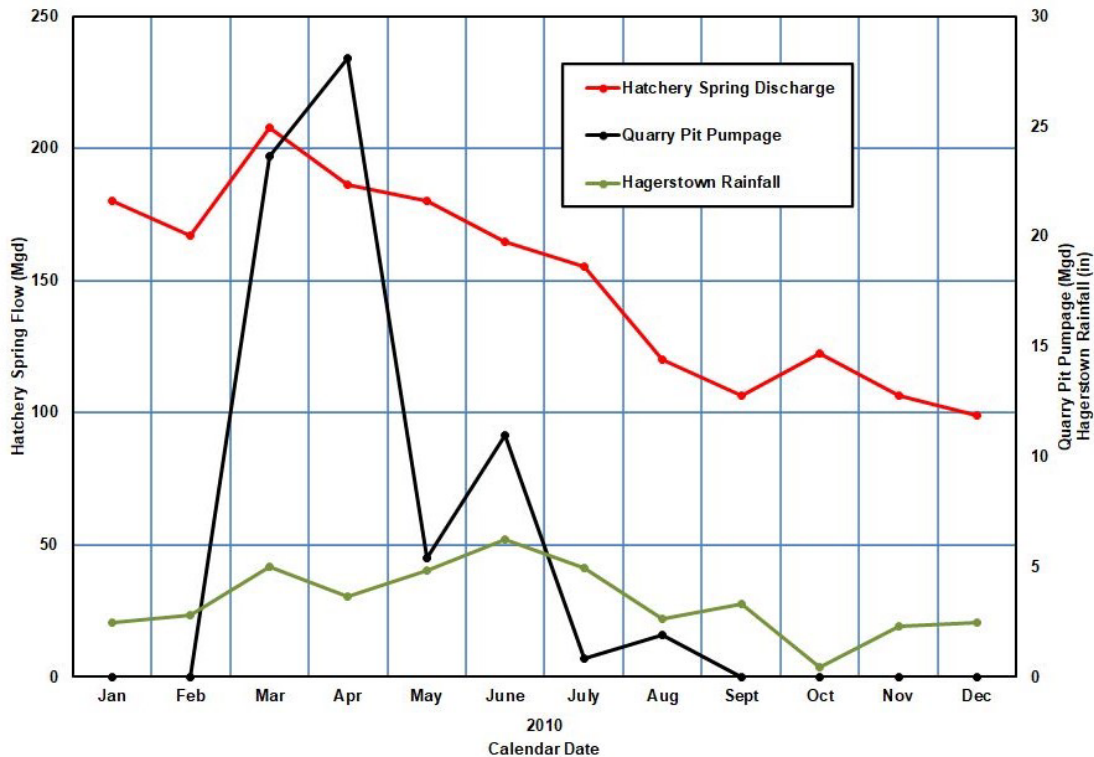
Figure 17. Monthly averages for the Beaver Creek West Quarry pit pumping rate, Albert Powell Fish Hatchery (Haupt Spring) spring flow and Hagerstown 1E rainfall: January to December 2010.

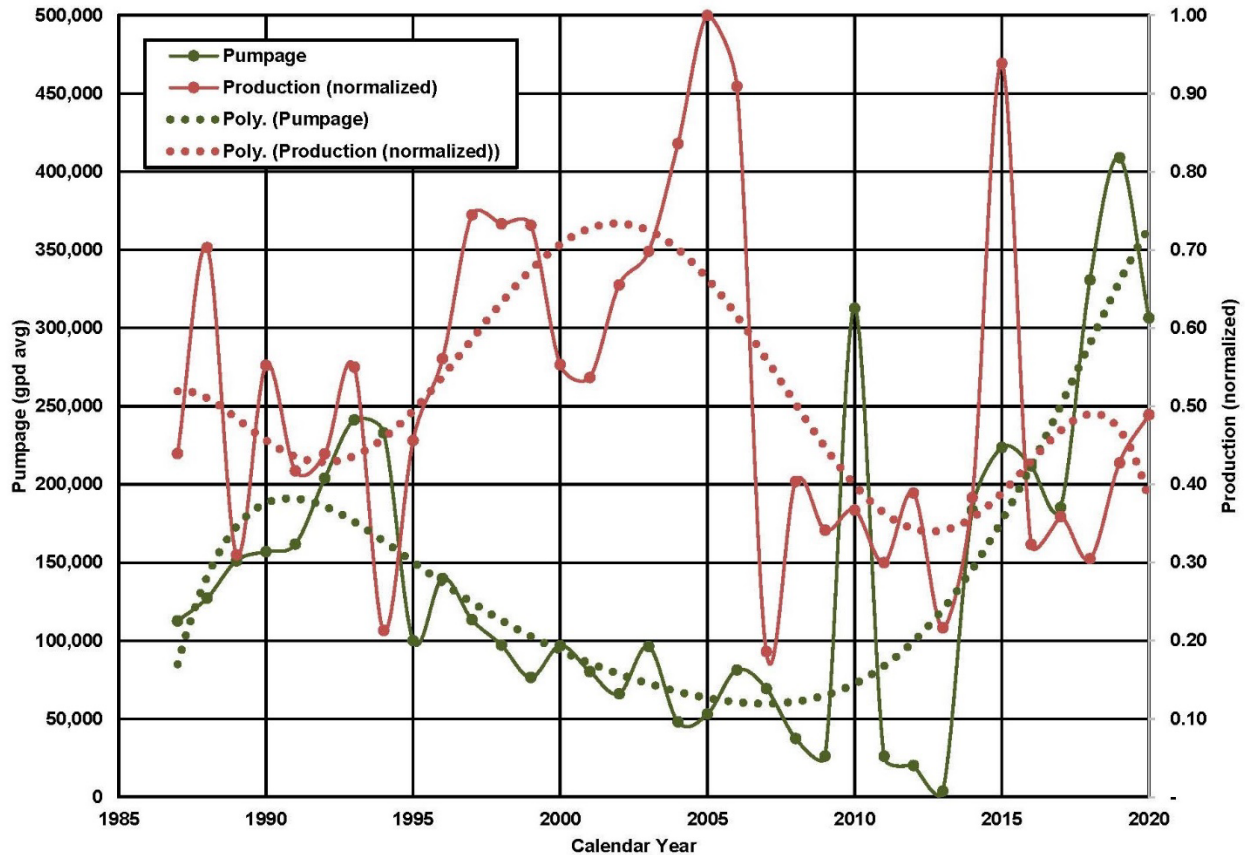
Figure 22. Annual averages for the Beaver Creek East Quarry pumping rate and normalized production: 1987 to 2005.

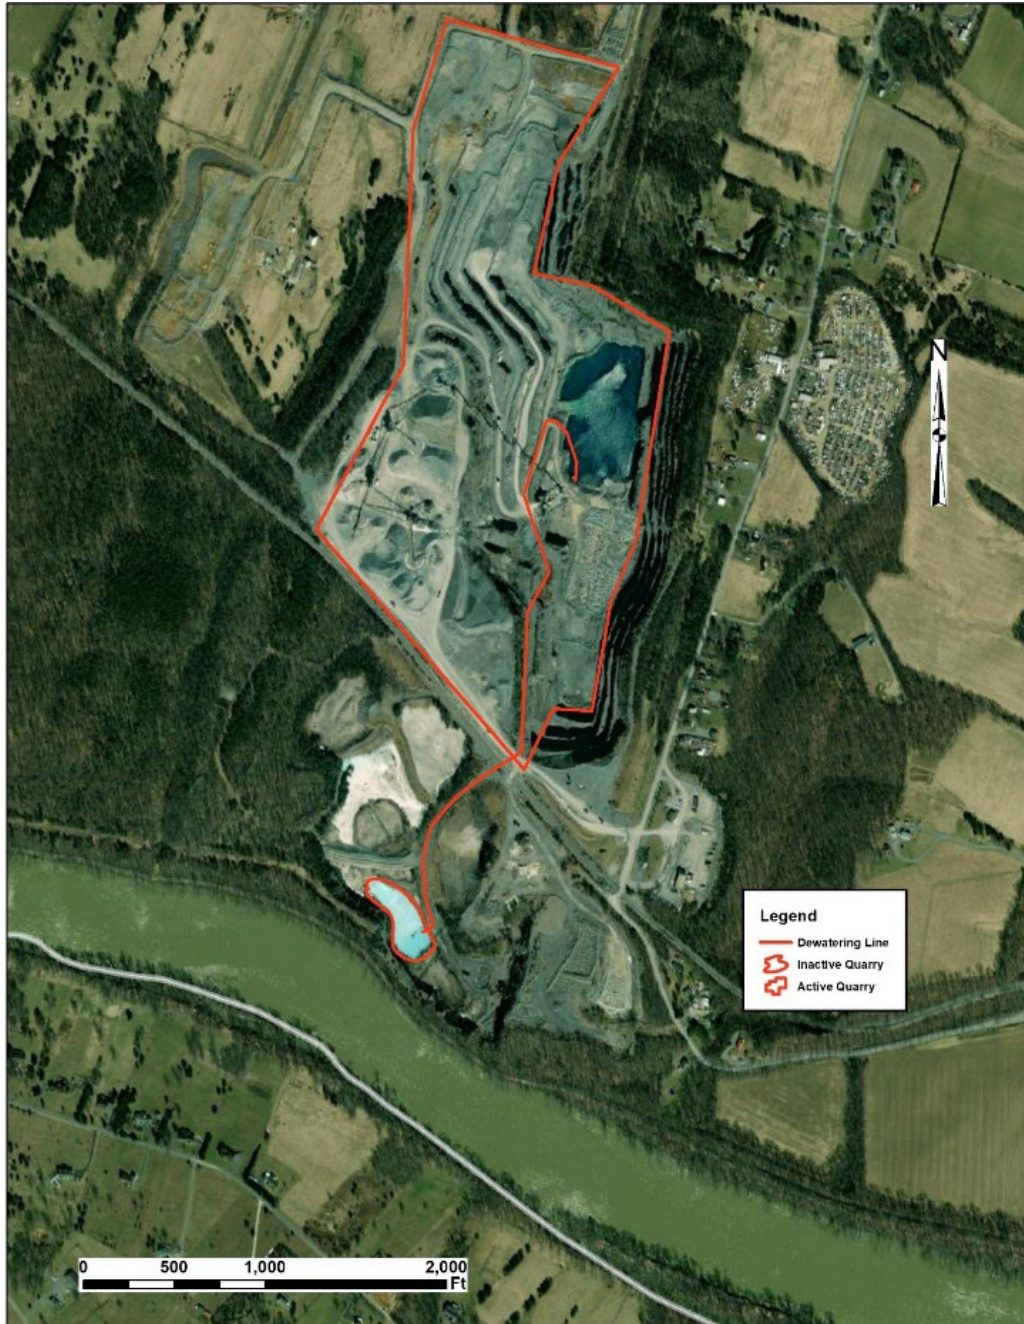
Figure 30. Aerial view of the Pinesburg Quarry showing dewatering line from the active quarry sump to the inactive quarry pond.

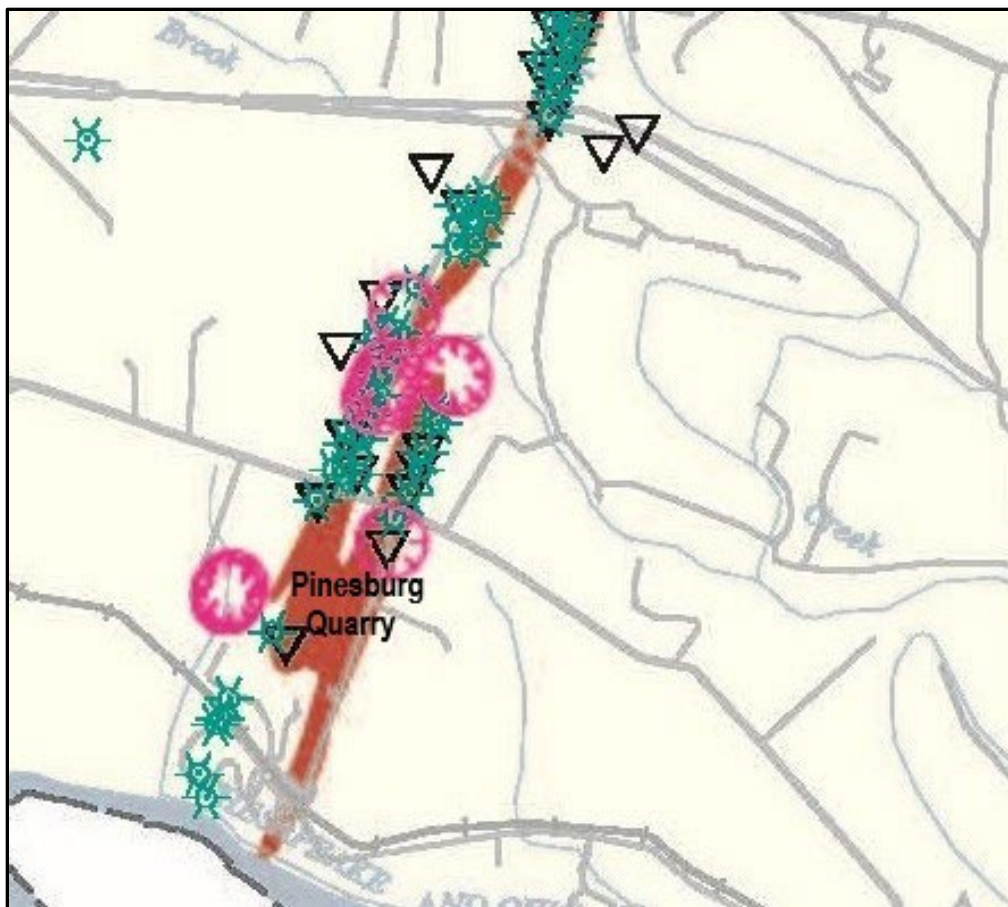
Figure 32. Location map showing karst features near the Pinesburg Quarry, modified from Duigon (2001). Pink features are collapse sinkholes.
