# The 2017 Oroville Dam Spillway Incident – What Happened and What Should We Learn?

John W. France, PE, D.GE, D.WRE  
JWF Consulting LLC

Maryland Dam Safety Training  
14 November 2018

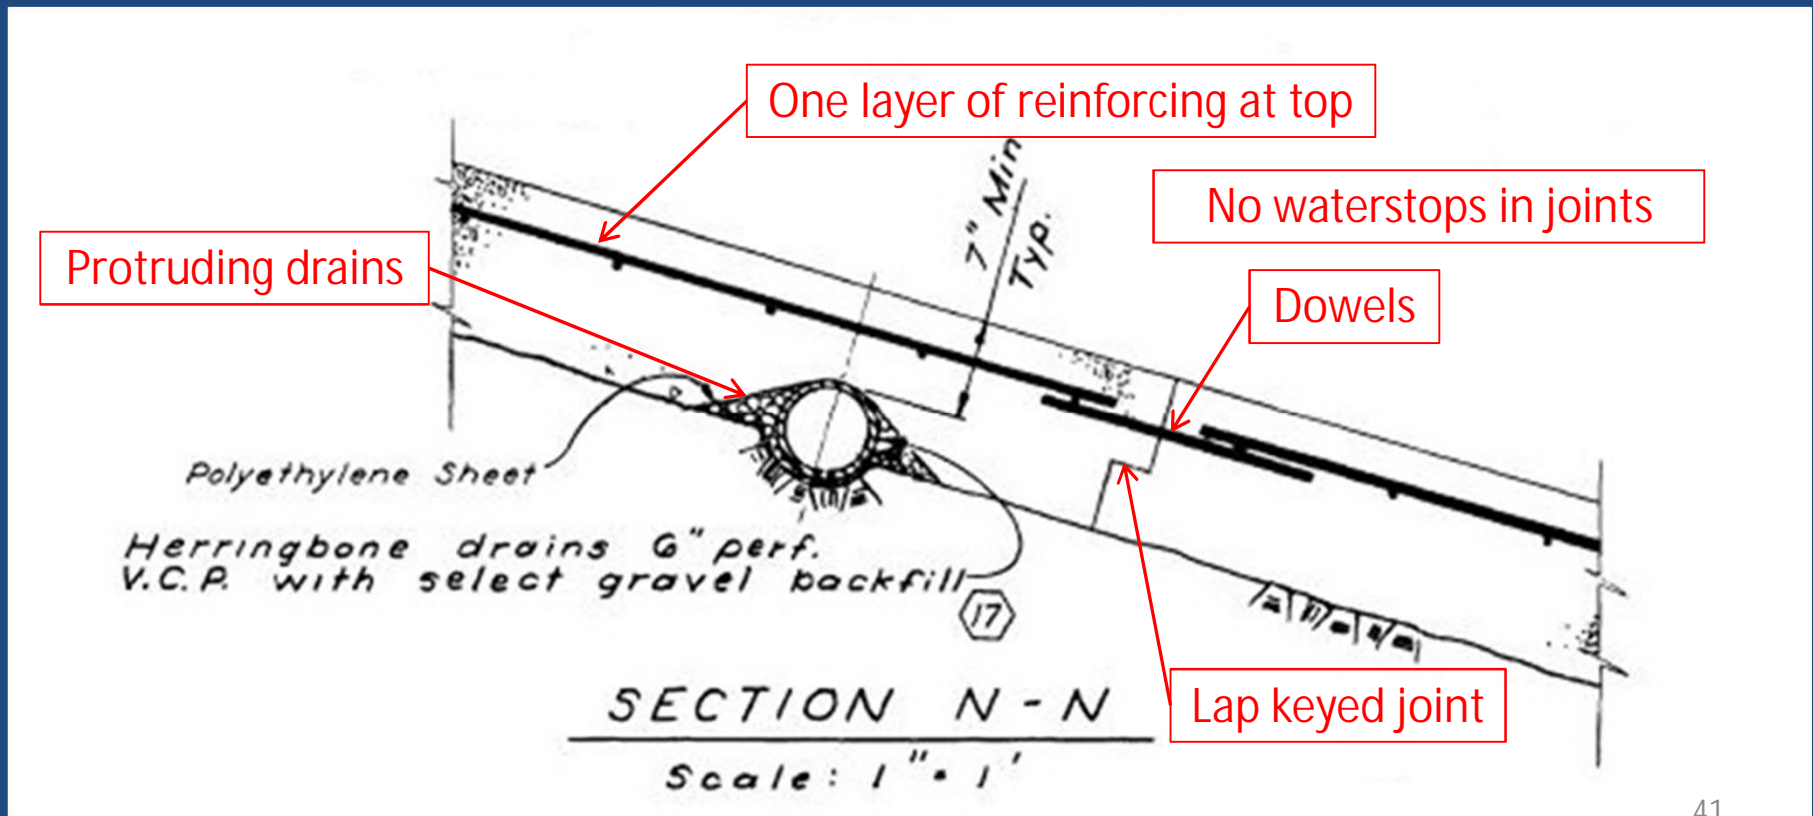
# Drain and Joint Details

- Nominal 15-inch thickness
- No waterstops in joints
- Dowels in joints
- Single layer of reinforcement near top of slab
- Lapped keys in transverse joints
- Keyed longitudinal joints
- VCP drains protruding into the slab
- Foundation anchors at 10-foot spacing, 5 feet into foundation
- 6-inch maximum size aggregate

- Within the range of other spillways of the time on rock, but generally in mid to low-mid range
- Drains protruding into section were at low end – less than 8 percent had protruding drains and none with as large a percentage of slab thickness
- Did not include typical details for soil foundations
- Not “best practices” of the time

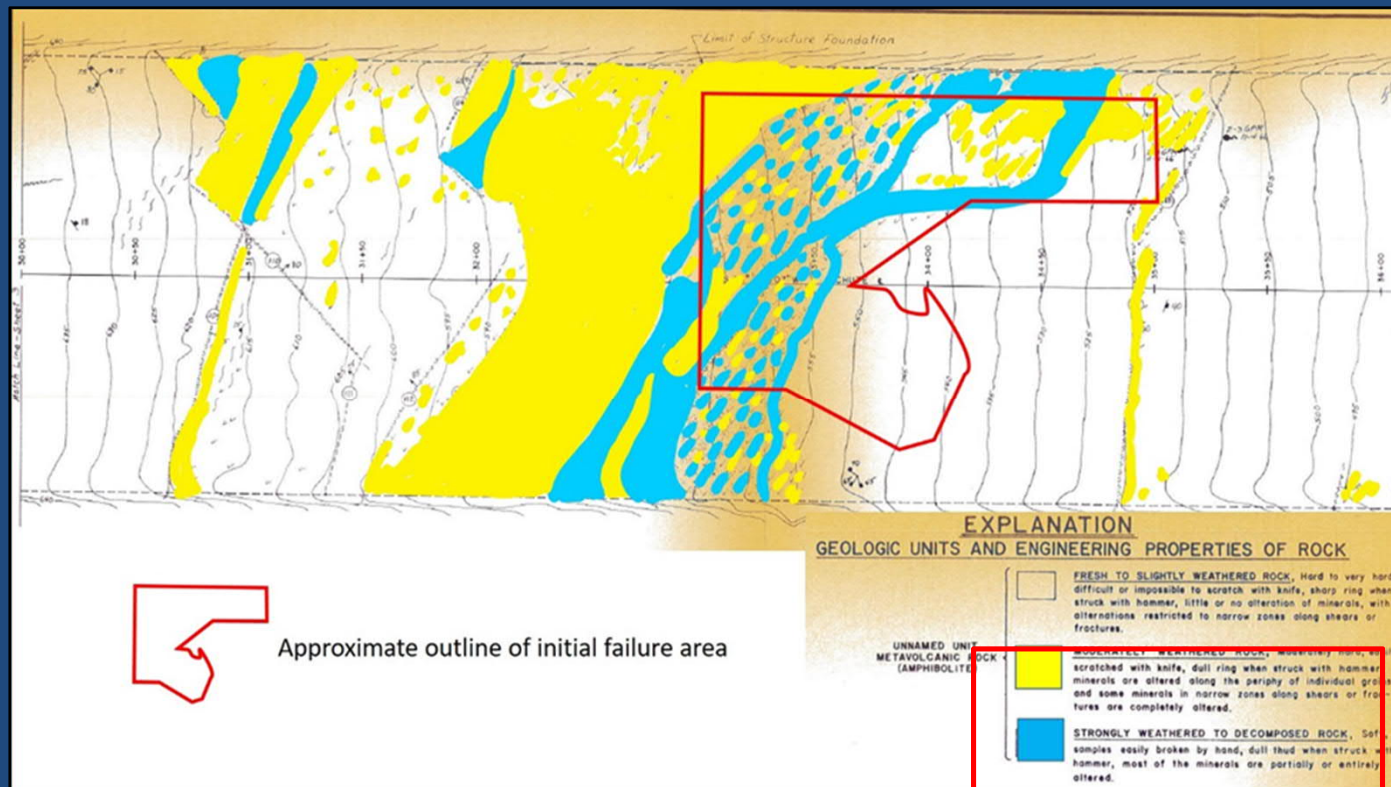
# Foundation at Initial Chute Failure Location

- Foundation preparation requirements were dramatically relaxed during construction
- Conditions varied
- Areas of “compacted clayey fines”
- Areas of strongly weathered rock
- No adjustments were made in anchors or other chute design details

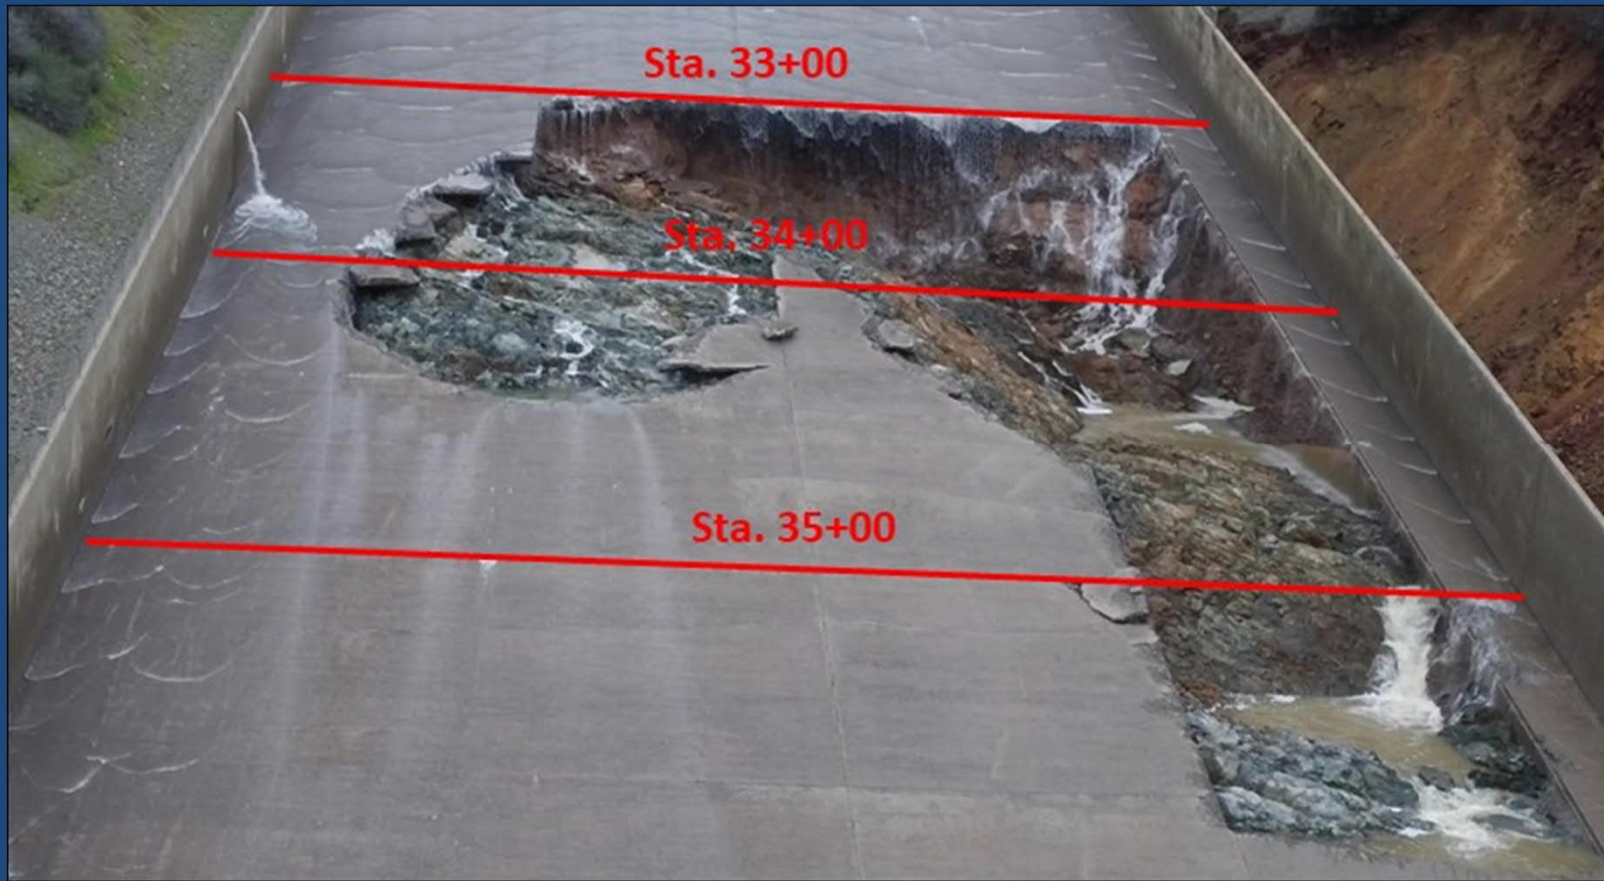
# Physics of SS Damage

- Foundation conditions (geology)
- Cracks in the slab
- Joints without waterstops
- Slab delaminations and spalling
- Corrosion and failure of reinforcing

- New chute slab damage and/or deterioration of previous repairs
- Expansion of shallow voids below the slab
- Corrosion and failure of reinforcing or dowels across cracks and joints
- Reduction in anchor capacity

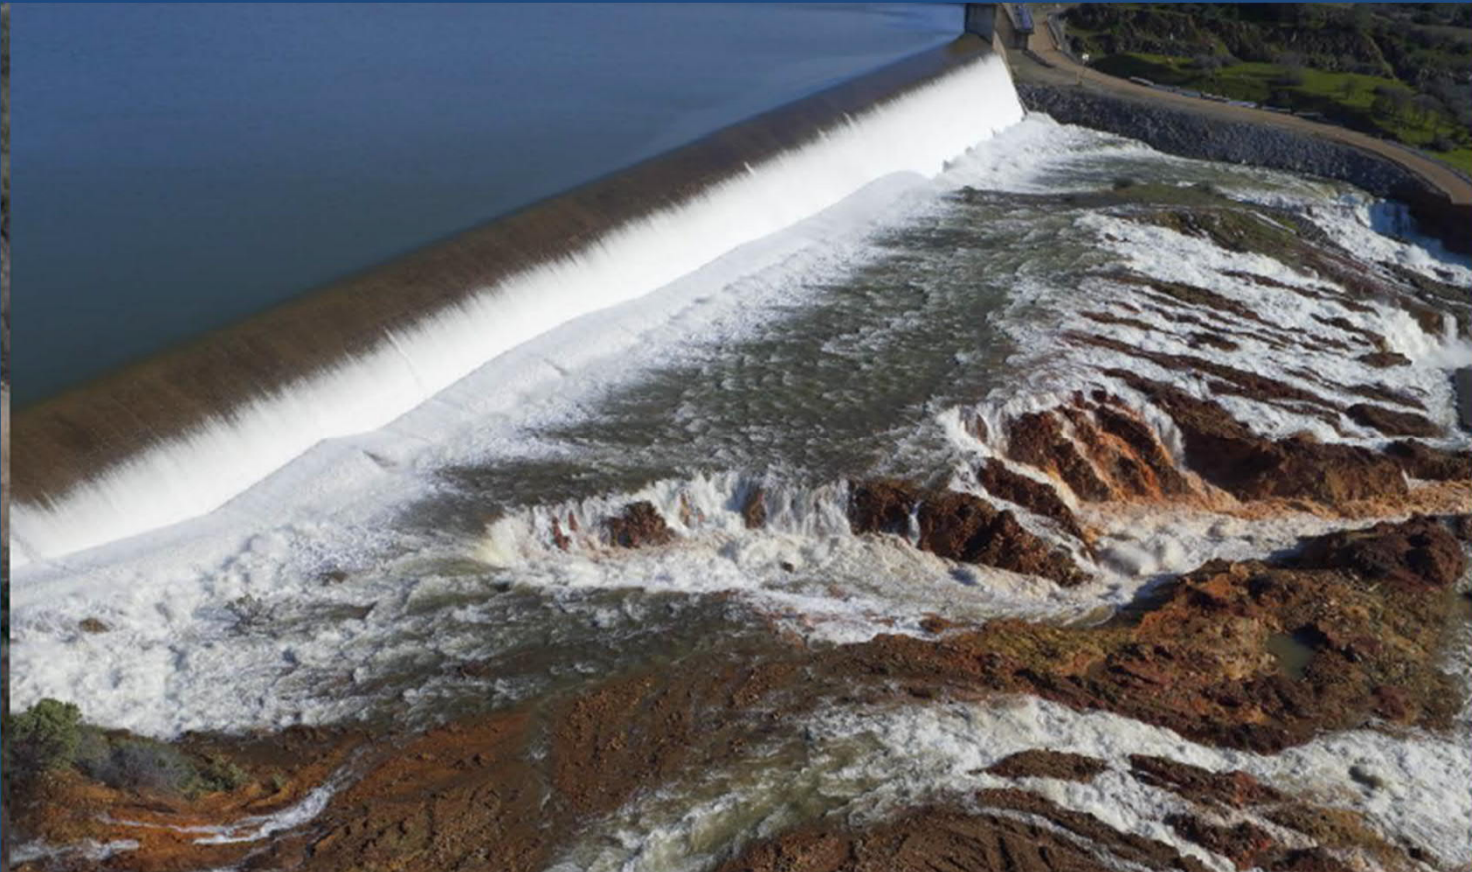
# What Happened – ES?

- Unfavorably oriented areas of erodible rock (geology)
- Flow concentrations
  - Topography
  - Infrastructure
- Insufficient energy dissipation at crest structure
- No erosion protection downstream of crest structure

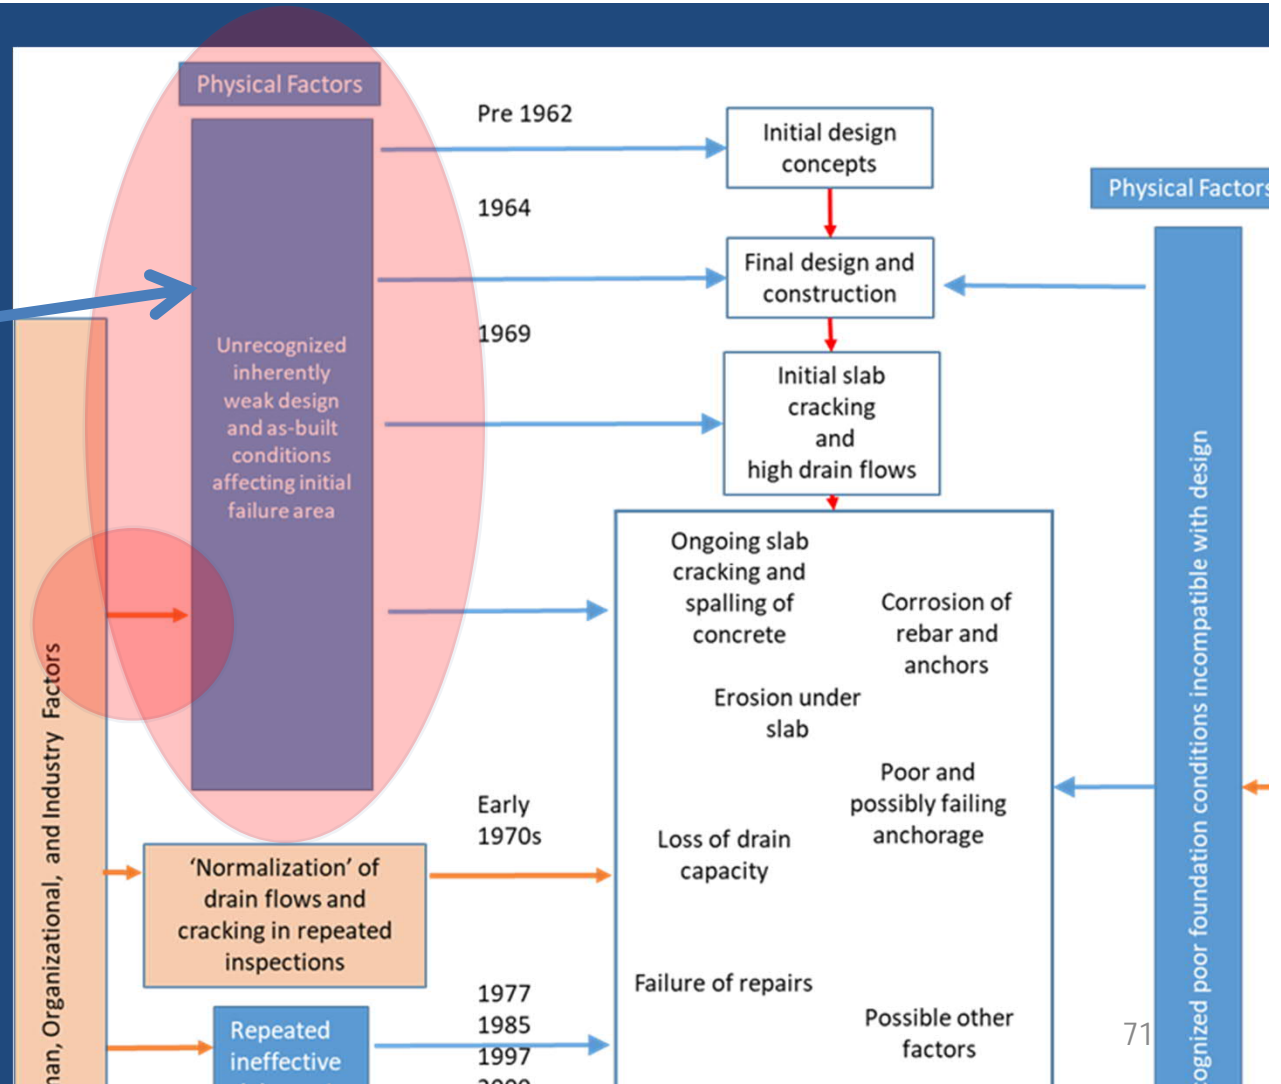
- Thin slab
- Protruding drains
- No waterstops
- Incompatible with foundation

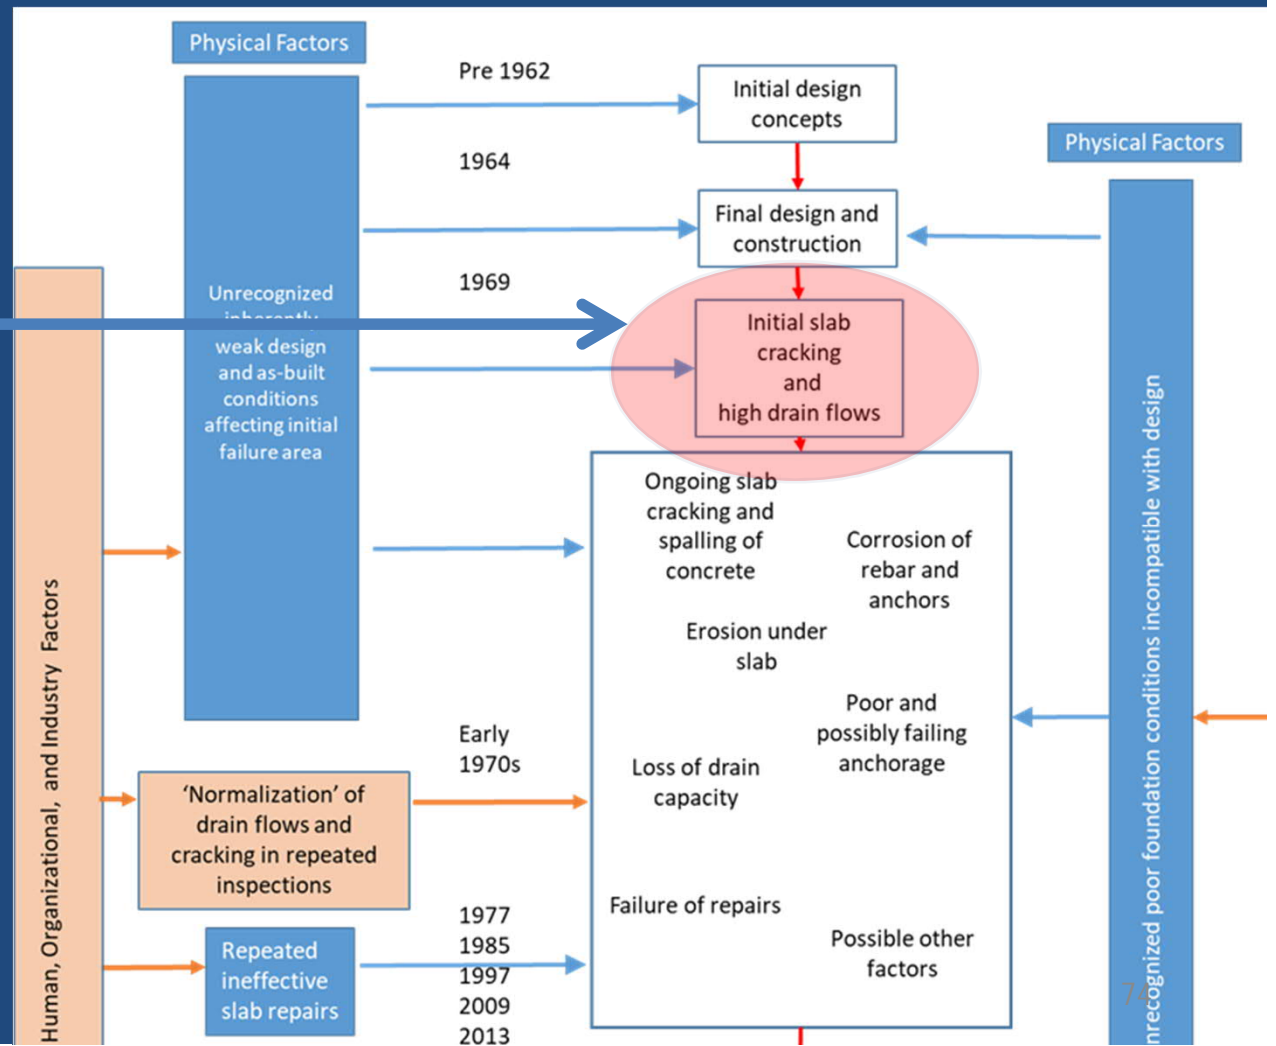
Major concerns in 1969  
"Should consult designer"

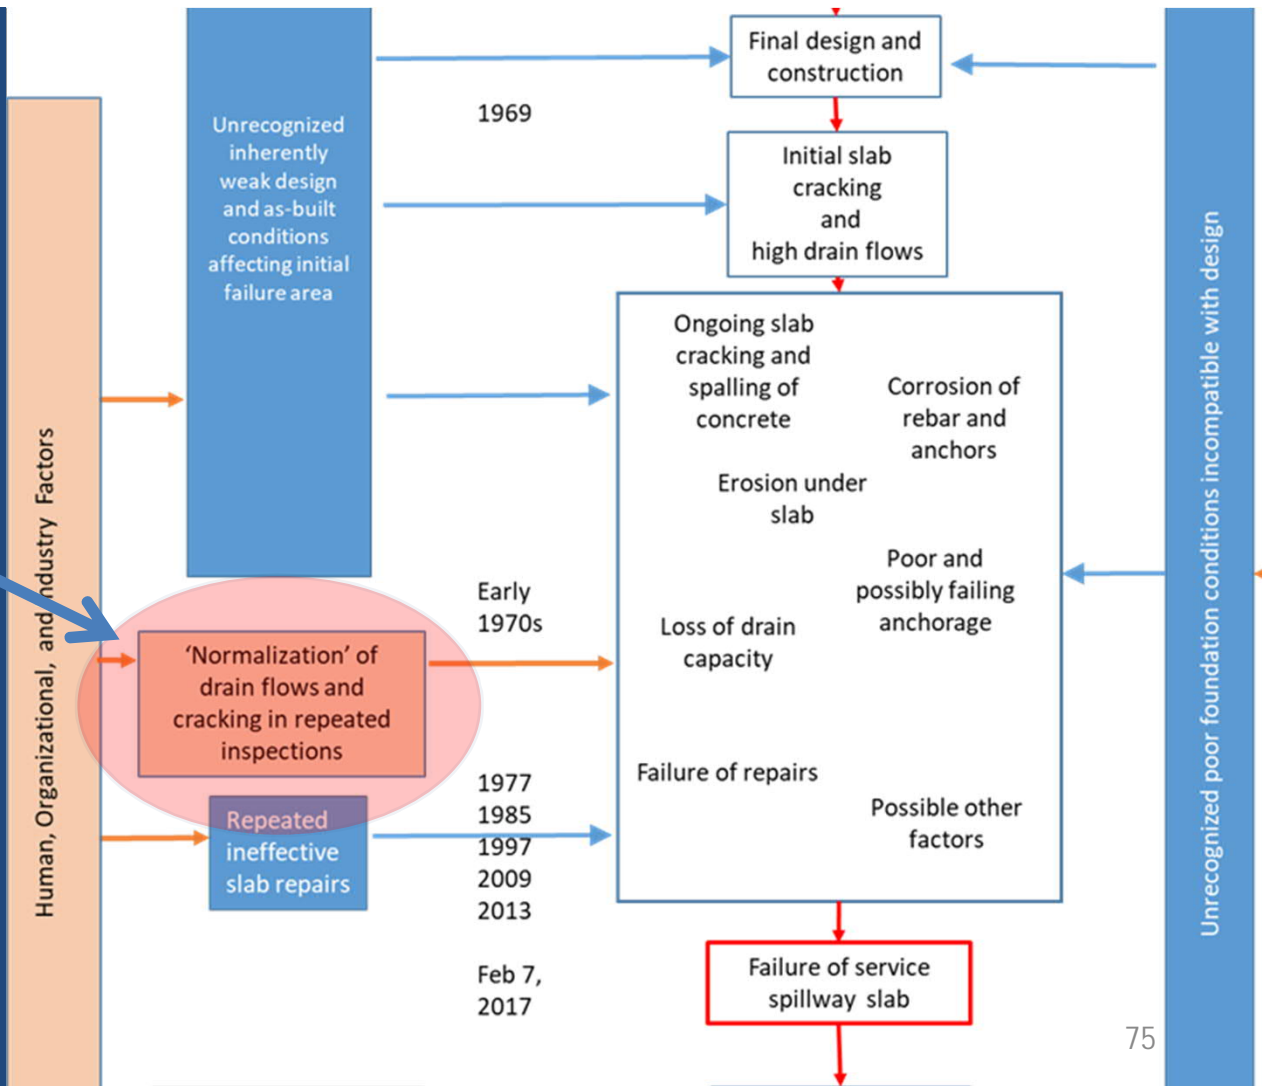
From "mystifying" to normal

- Cracking observed immediately after concrete placement
- Large drain flows observed during first spillway operation in 1969 – described as “mystifying” and ascribed to leakage through the slab
- Follow-up suggested, but not clear if there was follow-up
- Thereafter, cracking and drain flows were accepted as normal behavior

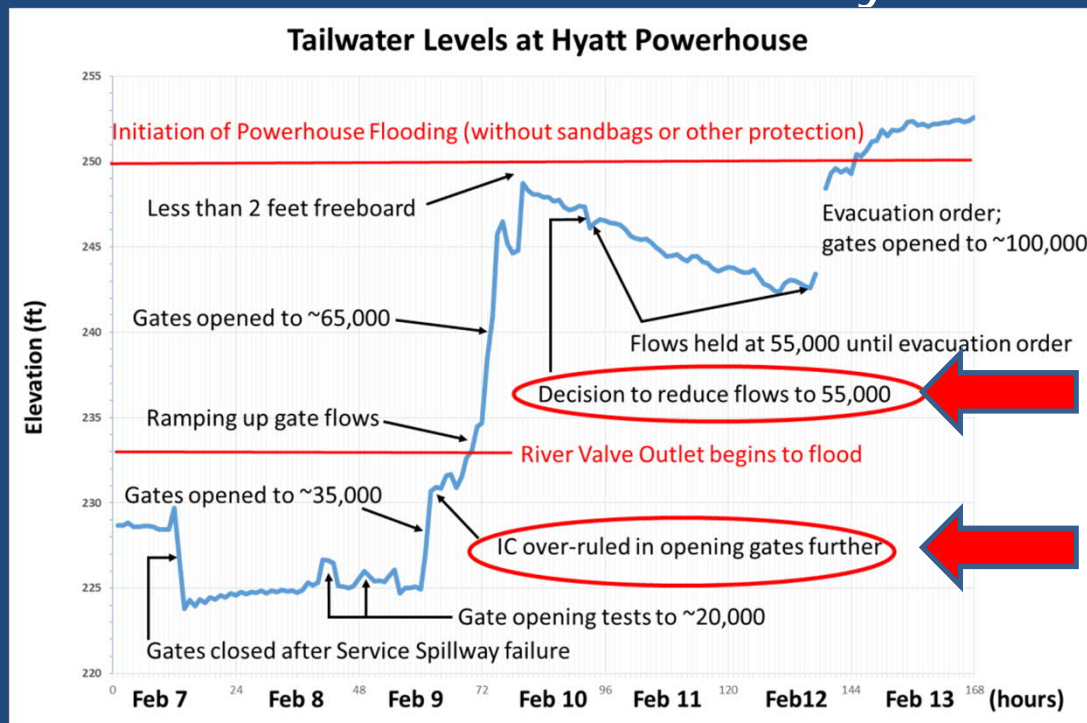
Specific decisions were made to limit service spillway flows, when threat from tailwater was actually diminishing
