RESPONSE ACTION PLAN

1401 WOODALL STREET PROPERTY

Baltimore, Maryland

GEO-TECHNOLOGY ASSOCIATES, INC.

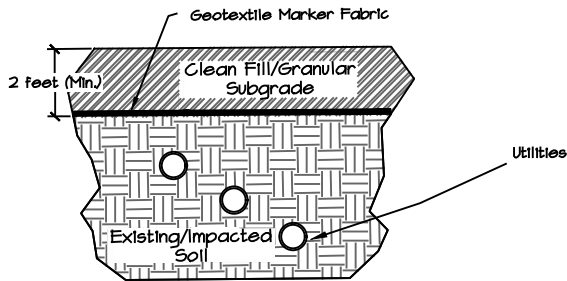
LANDSCAPED AREA (SOIL/STONE)
Typical Section

Pervious capping will include the landscaped areas and areas to be covered by stone. These areas will be capped with a minimum of two feet of MDE-approved residential-grade clean fill. The thickness of the cap can be increased during grading or during landscaping following grading as an option to accommodate the planting of different species in order to ensure the minimum clean fill requirements and accommodate the plant's root ball. The pervious capping will eliminate the direct contact exposure risk to future occupants or users of the site. A total of at least two feet of MDE-approved residential-grade clean fill material above a marker barrier will be placed in areas of pervious capping. Details of the capping are illustrated in *Figure 4*.

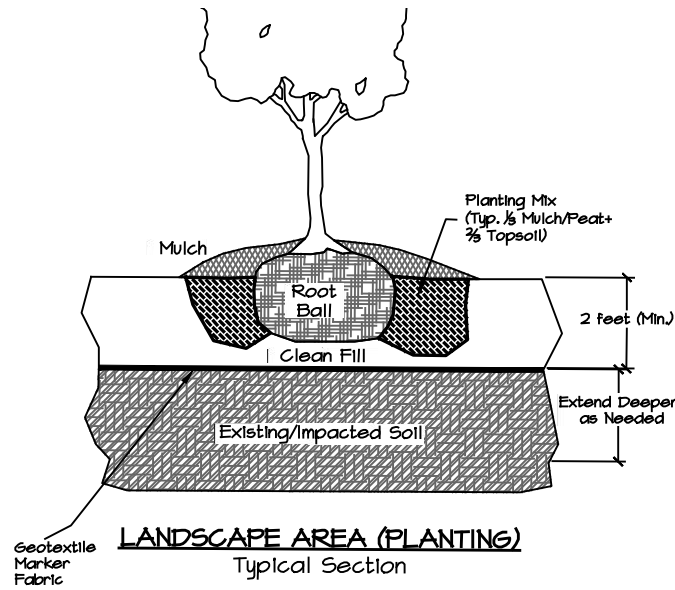
LANDSCAPE AREA (PLANTING)
Typical Section

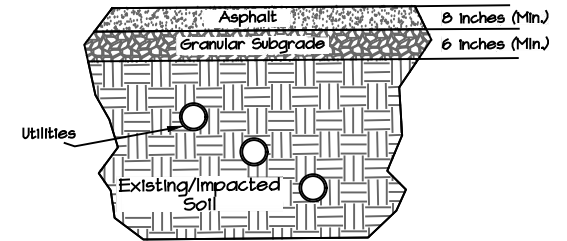
ASPHALT ROADWAY (STABLE SOIL)
Typical Section

The foundation of the building will act as a cap for the northern section of the subject property. The southern section is proposed to be capped with a playground, new asphalt pavement parking lot, and limited areas of landscaping. The impervious cover is currently planned to generally consist of a minimum of six to eight inches of granular sub-base and four to eight inches of asphalt or concrete over native material or clean fill, as illustrated on the final approved grading plan. Based on preliminary grading estimates, the reuse of onsite materials is anticipated. In areas where fill is required, the onsite soil stockpiles or other excavated material from onsite utility installation etc. will be utilized with approval from the MDE. Details of the capping are illustrated in *Figure 4*.

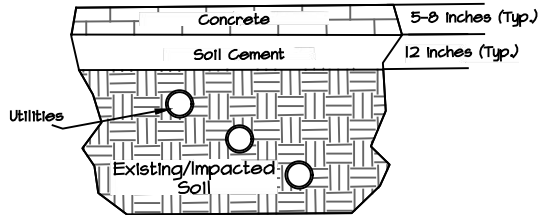
HARDSCAPED AREA (SOFT SOIL)
Typical Section

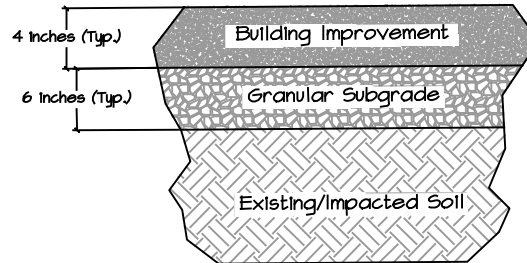
BUILDING SLAB
Typical Section

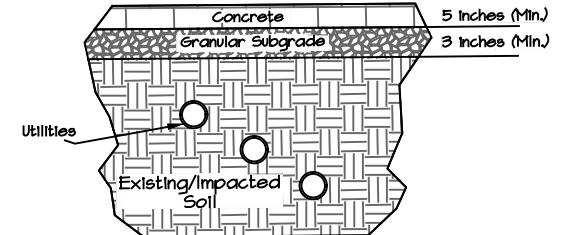
CONCRETE SIDEWALK (STABLE SOIL)
Typical Section
