Jabez Branch Monitoring Report Pre-Restoration Conditions - Year 3 (2019)

Neal Eshleman¹, Molly Reynolds², Daniel Spradlin²

1 Maryland Department of Natural Resources, Resource Assessment Service, 580 Taylor Avenue Annapolis, Maryland; **2** Coastal Resources, Inc., 25 Old Solomons Island Road, Annapolis, Maryland

April 2020

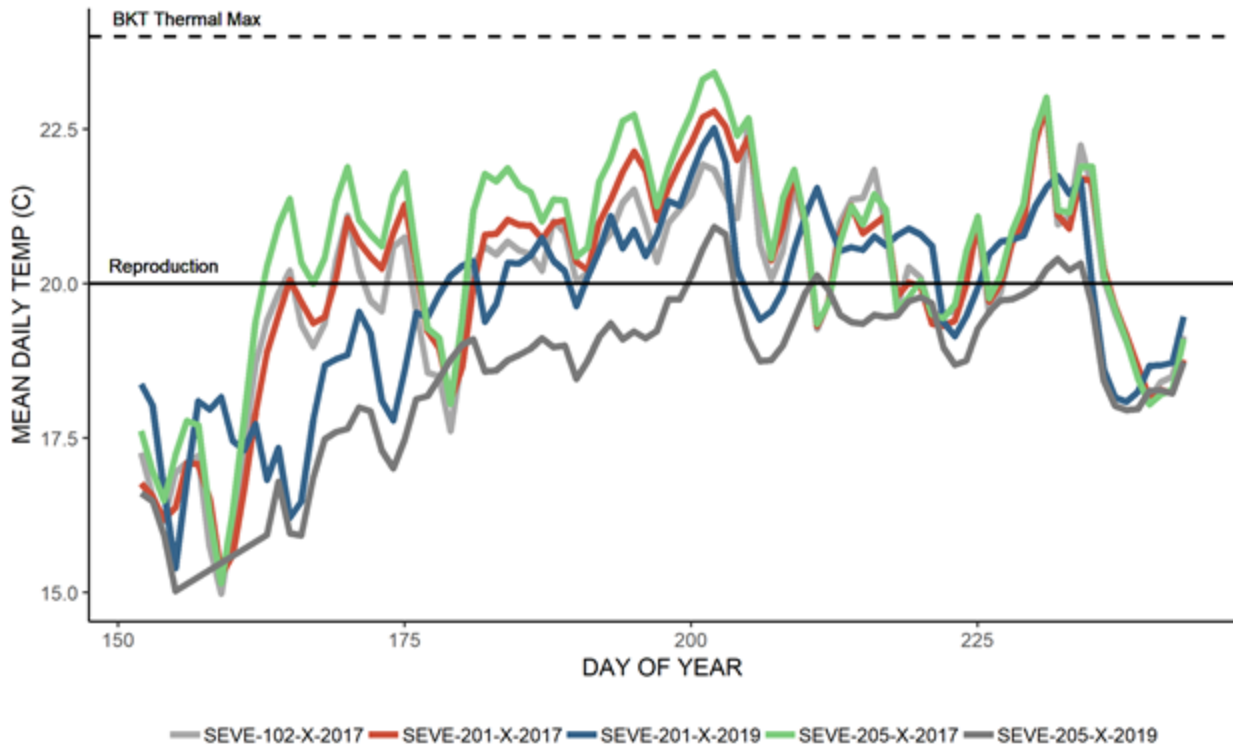
Figure 6. Mean daily temperatures at Jabez Branch with trout thermal tolerances.

Daily average stream temperatures observed in Jabez Branch did not exceed the thermal maximum for Brook Trout survival (24°C) (**Figure 6**), but commonly exceeded the 20°C threshold for reproducing trout streams during summer months. No temperature data collected at Jabez Branch met MDE’s criteria for Use-Class III streams. The range of temperatures in Jabez Branch were within the upper limits of temperatures experienced at MBSS sites where brook trout were collected (**Figure 7**), suggesting that thermal conditions within Jabez Branch may be at least marginally suitable for brook trout populations.

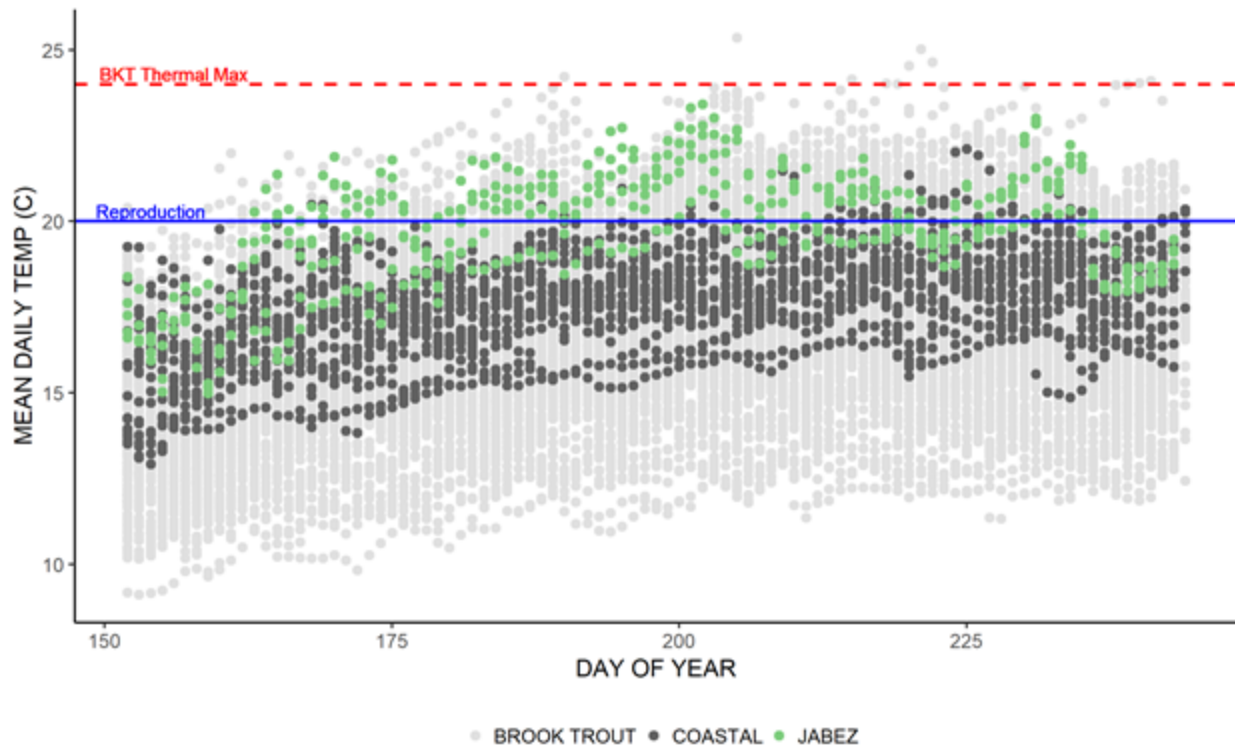
Figure 7. Temperature ranges for MBSS coastal plain streams meeting MDE’s Use-Class III criteria, MBSS brook trout streams, and Jabez Branch with trout thermal tolerances.
